2020

BRIDGE CONDITION REPORT

City, County, Railroad and Private Bridges

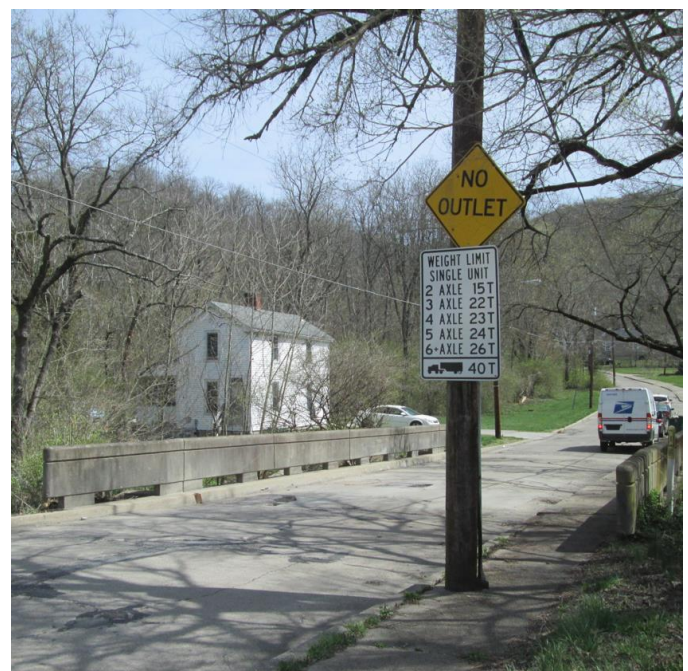
There are two County bridges with load restrictions for commercial loads. The East Fork Rd Bridge over the Duck Creek has been posted since 1993 due its condition. The Western Hills Viaduct was load posted in spring 2020 due to a combination of new legal loads and capacity reductions due to the condition of the structure.

East Fork Bridge with Load Posting Sign

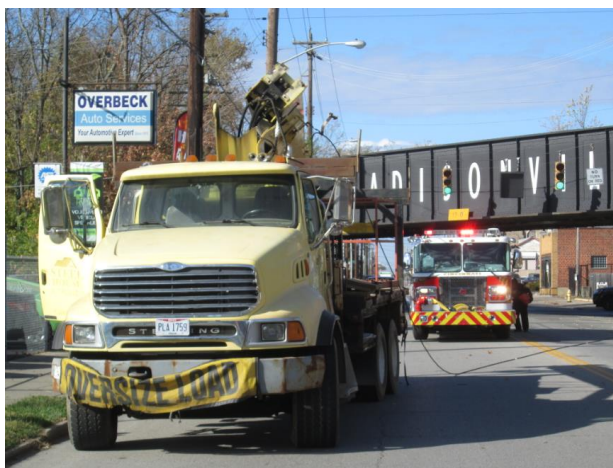
In 2020, as in years past, there were numerous cases of drivers ignoring vertical clearance restrictions and colliding with overhead structures. The most impacted bridges in the city limits are the railroad overpasses over Collins Ave and Madison Rd at Kenwood, despite a new advanced warning system for Madison Rd truck traffic.

Vehicle after impact with railroad bridge at Madison Rd near Kenwood.

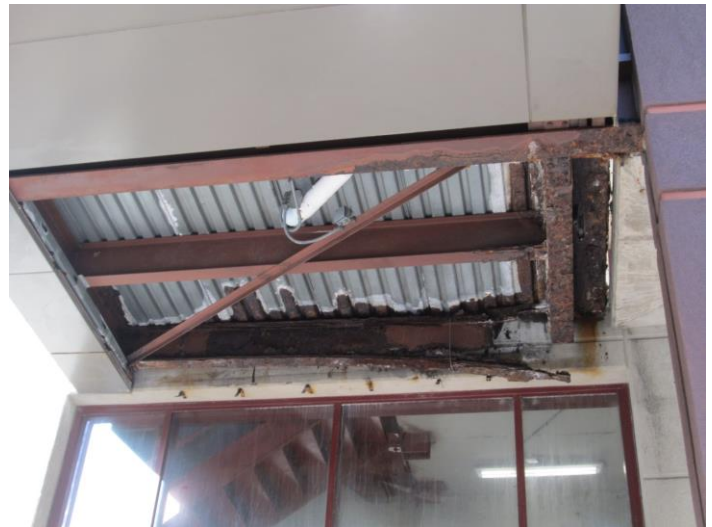
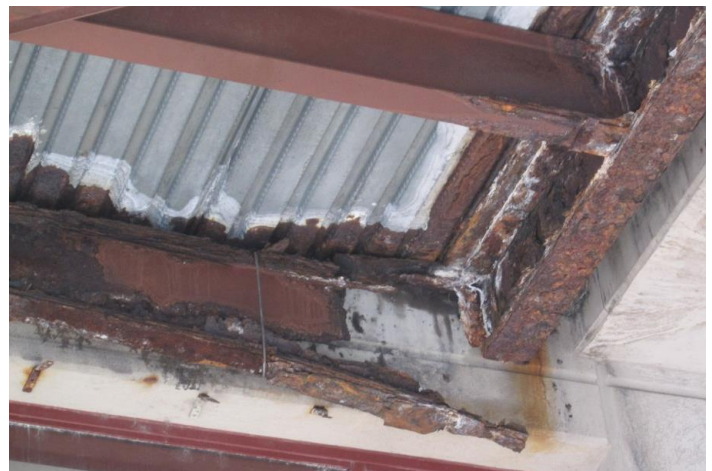
The only bridge with a condition rating of 1 is the *Plum Street Pedestrian Overhead North of 6th Street*. This City Skywalk bridge is owned and maintained by the Port of Cincinnati. Removal of some cladding panels revealed the severe deterioration of some of the concealed structural members. The bridge was immediately closed to all traffic and shored. The port has been working with a consultant to develop repair plans, and construction is currently underway.

Above and below: Deteriorated floorbeam at the Plum Street Pedestrian Overpass north of 6th Street.

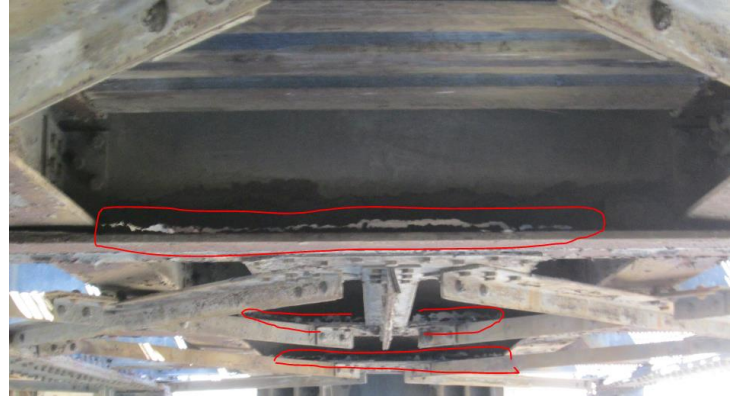
The third one is the *Gest Street Chessie Overhead – 1st East of Mill Creek* which is owned and maintained by CSX. The condition of the floorbeams with perforated members is controlling the rating. The concerns have been brought to the attention of CSX.

Above: Perforated floorbeams under the Gest Street Chessie overhead – 1st East of the Mill Creek.

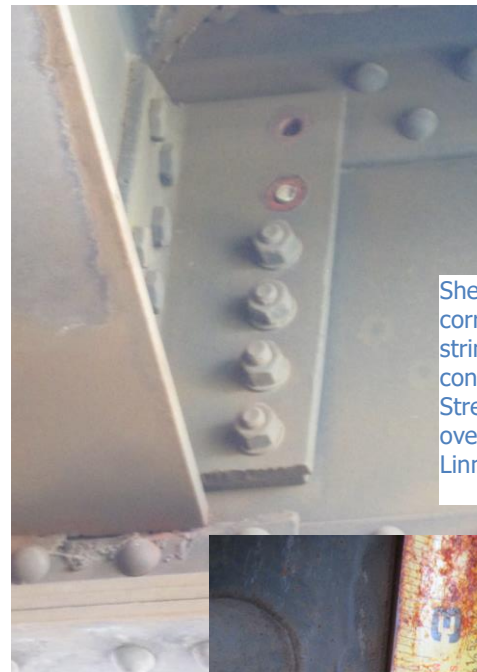
Sheared off bolts and corrosion holes at stringer to floorbeam connection on the 5th Street Chessie overhead west of Linn Street

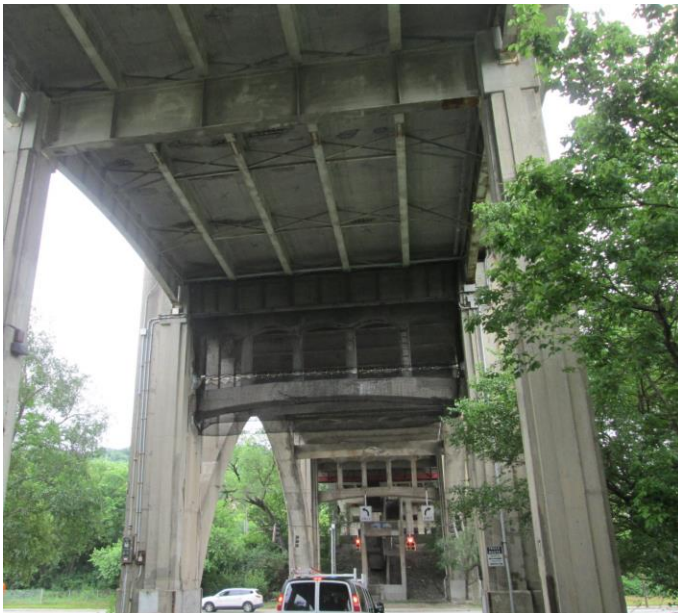
The existing viaduct is rated in poor condition (condition rating of 4). It is structurally deficient due to advanced and widespread deterioration of numerous members, is posted for weight limits, and is also functionally obsolete, meaning it does not meet current roadway geometric standards. At locations where the deterioration is at its worst, supplemental supports have been added beneath the bridge to avoid a partial closure, which would restrict traffic from the lower deck. Spalling concrete falling from the upper deck to the lower deck is a continual safety problem which is being routinely addressed by installation of netting at a critical area and regular closures of the lower deck in order to remove loose and delaminated concrete.

Debris netting under the Western Hills Viaduct west of Spring Grove Avenue
