**PROGRESS REPORT #5
CINCINNATI PARKS INFRASTRUCTURE ASSESSMENT
CINCINNATI PARK BOARD
PROJECT NO. 19087**

November 24, 2020

**Cincinnati Park Board
Infrastructure Assessment
Brandstetter Carroll Inc.
November 24, 2020**

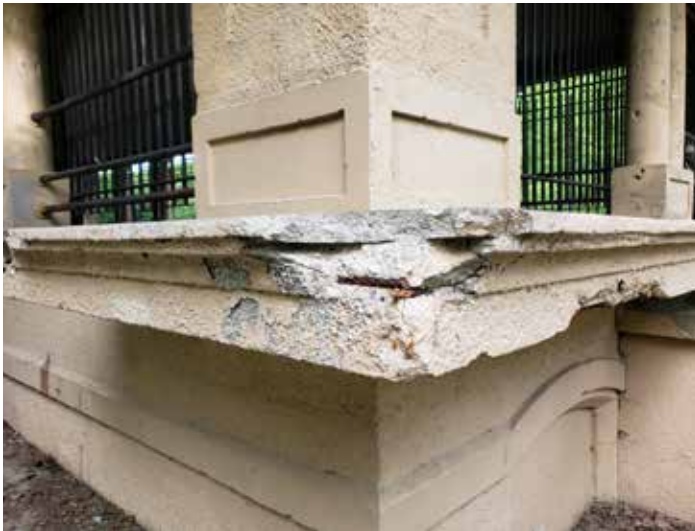
Overall, the Team's analysis finds that those facilities used for their intended purposes are in very good condition. However, there are significant issues with those facilities which are no longer used and are not maintained. For example, Inwood Pavilion is over 100 years old and a former pool bathhouse and pavilion. Since the removal of the pool a function and use for the space has not been determined. As a result, the facility has fallen into disrepair to the point that it will take significant renovation to save the historic structure. As another example, former concession stands that are now used for storage have considerable structural degradation.

1. Inwood Pavilion decaying exterior

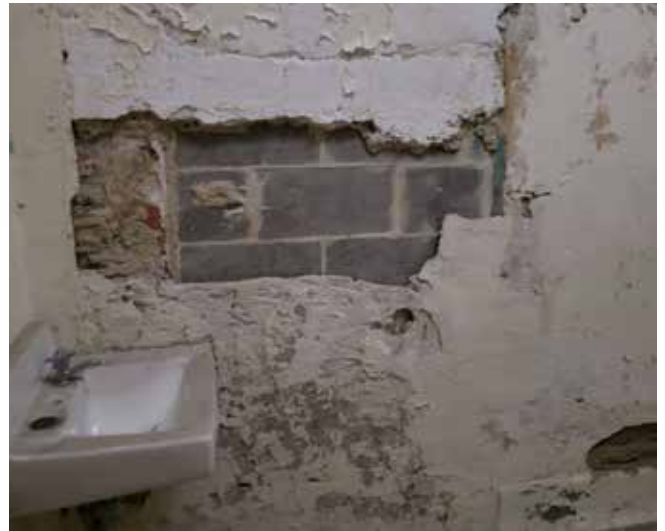
2. Inwood Pavilion decaying interior

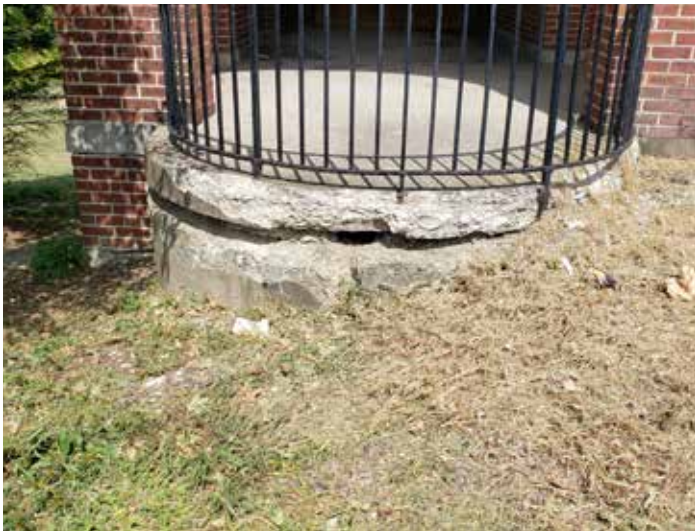
3. Owls Nest Pavilion exterior

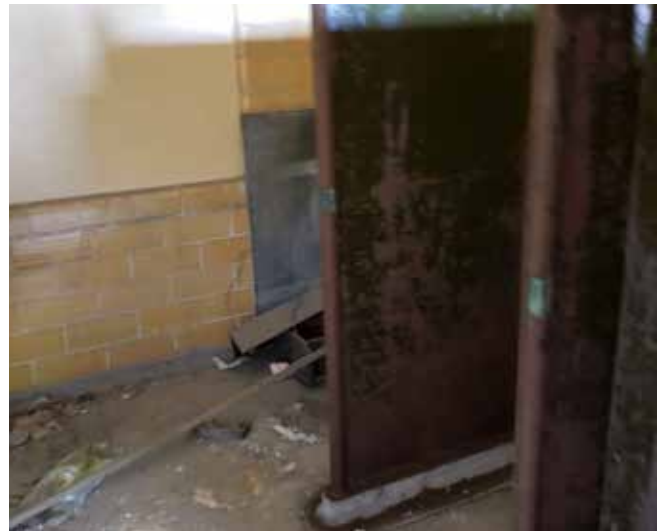
4. Owls Nest Pavilion interior

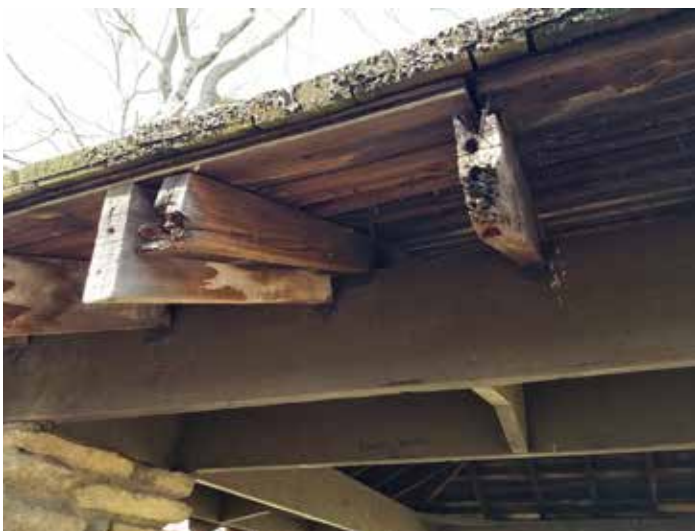
5. Mt. Airy Area 23 shelter

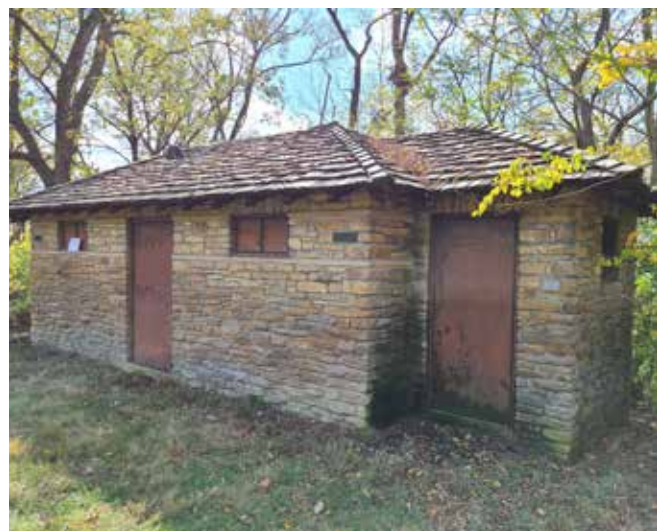
6. Mt. Airy Comfort Station closed for 30 years

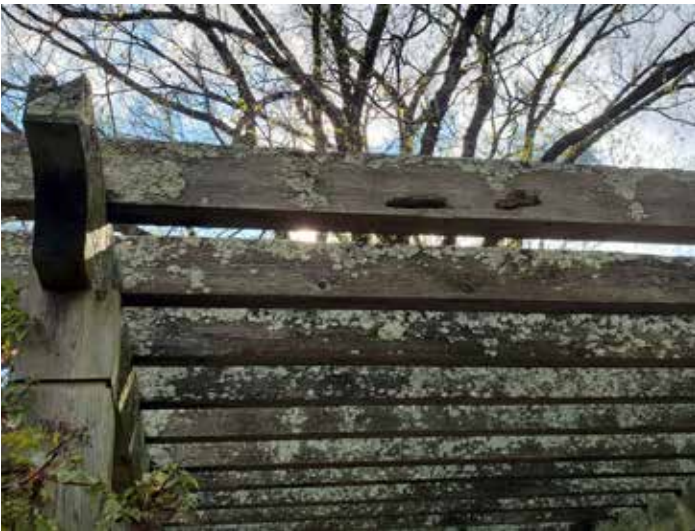
7. Lichens and insect damage at Ault Pergolas

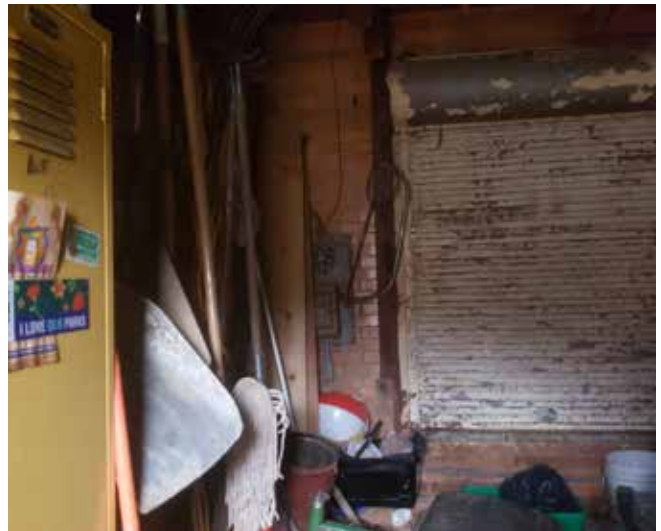
8. Burnet Woods concession used for storage

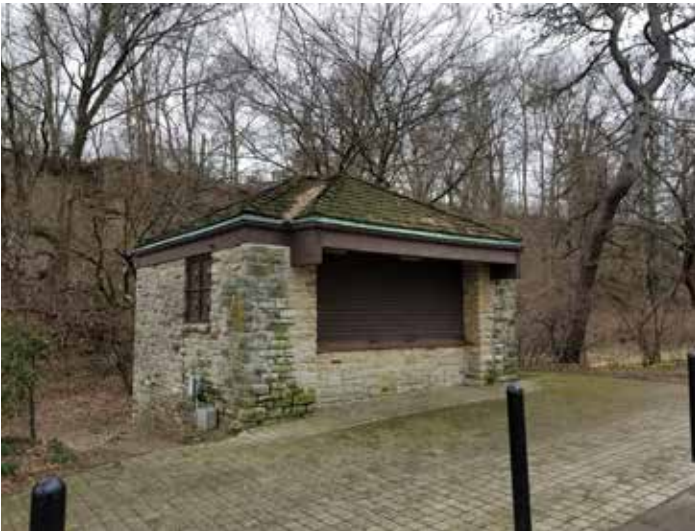
9. Eden Twin Lakes concession used for storage

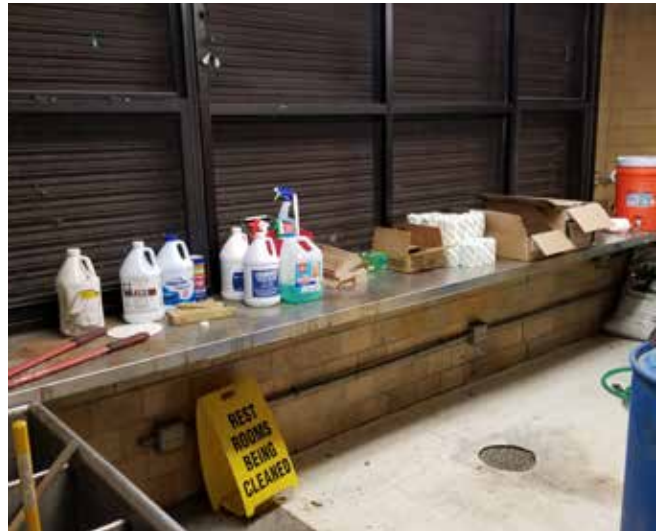
10. Eden Twin Lakes used for storage

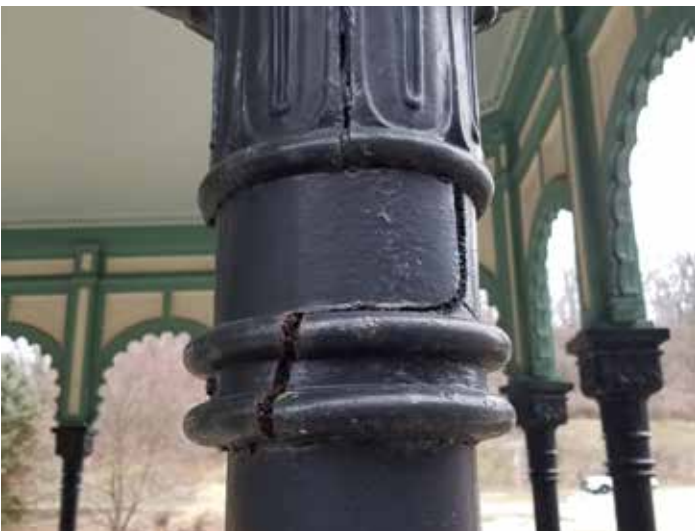
11. Cracked post at Eden Park

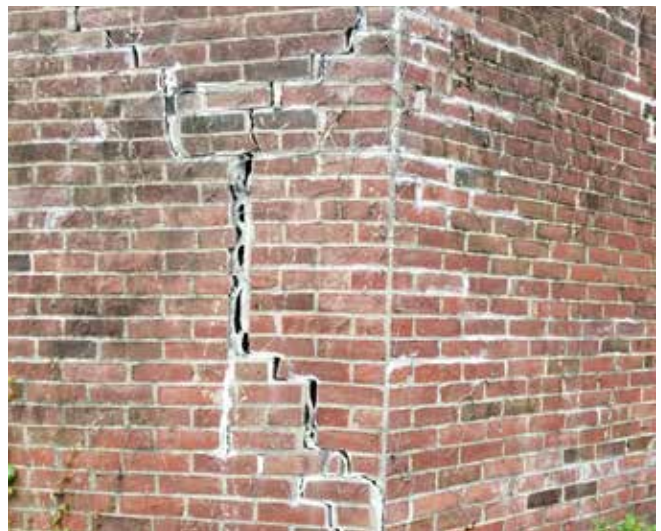
12. Cracked walls at Eden HQ Building

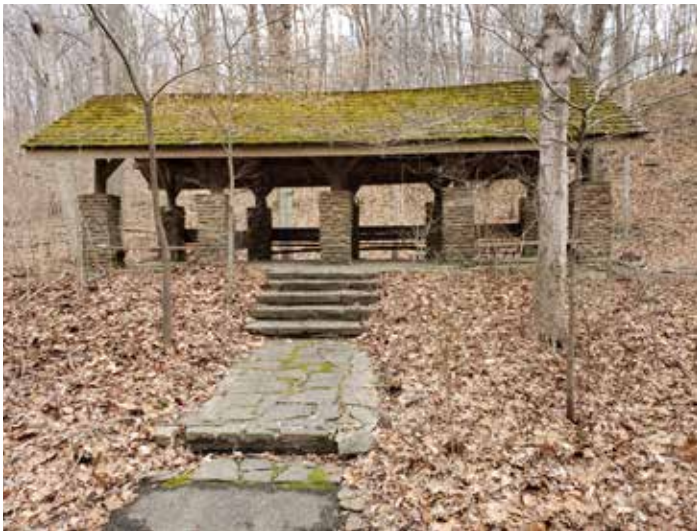
13. California Woods sagging roof on shelter

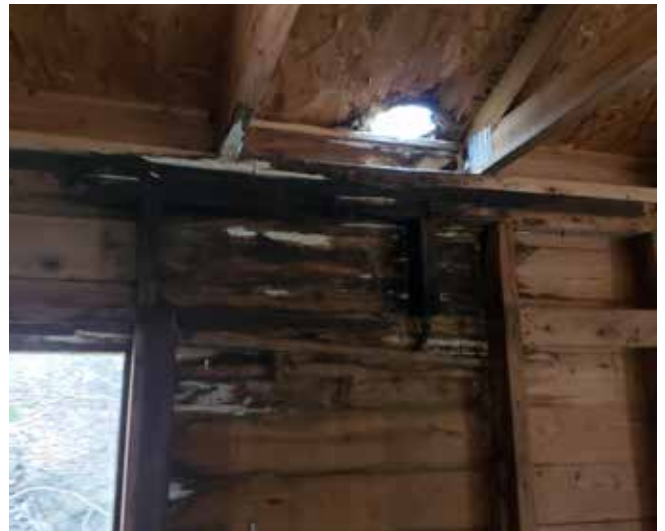
14. California Woods Schoolhouse roof

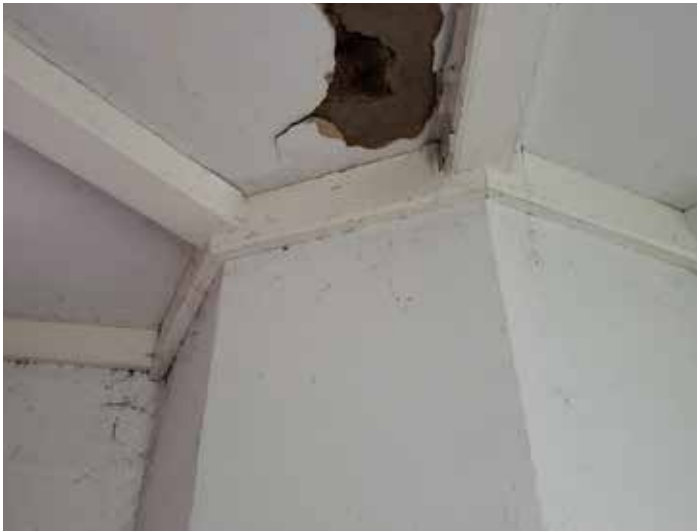
15. Seasongood Square CS interior damage

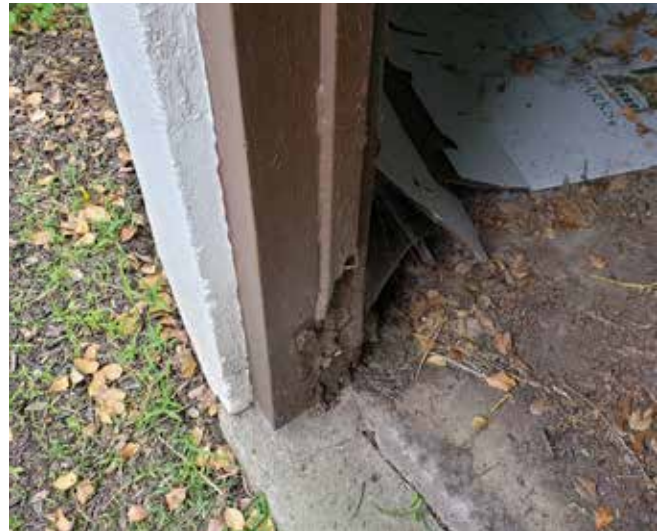
16. Seasongood Sq. CS rusted door frame

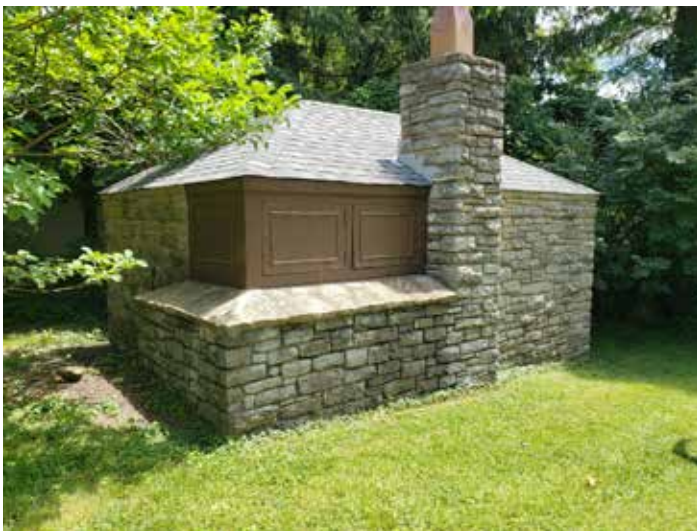
17. Wulsin unused former comfort station

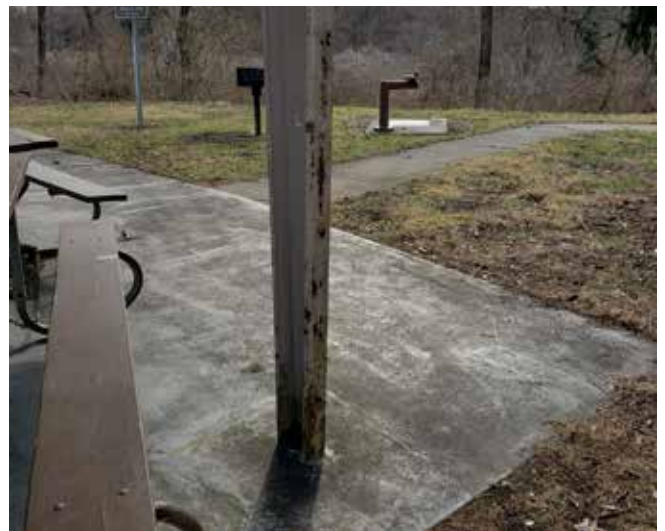
18. Stella Shelter rusting posts

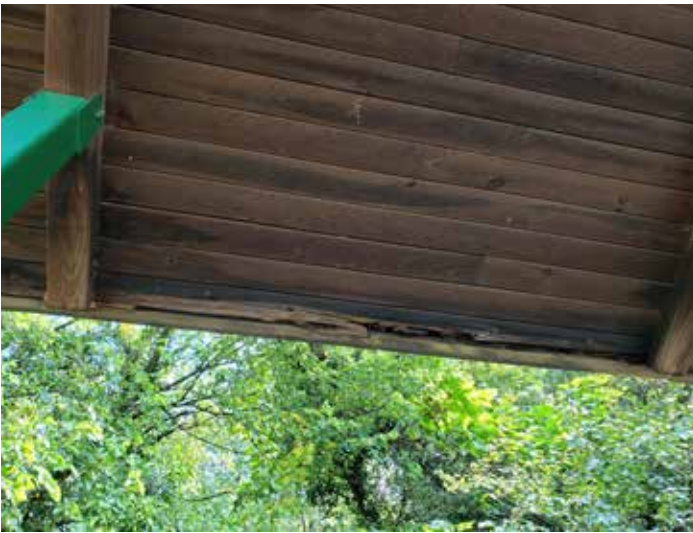
19. Fairview Shelter roof damage

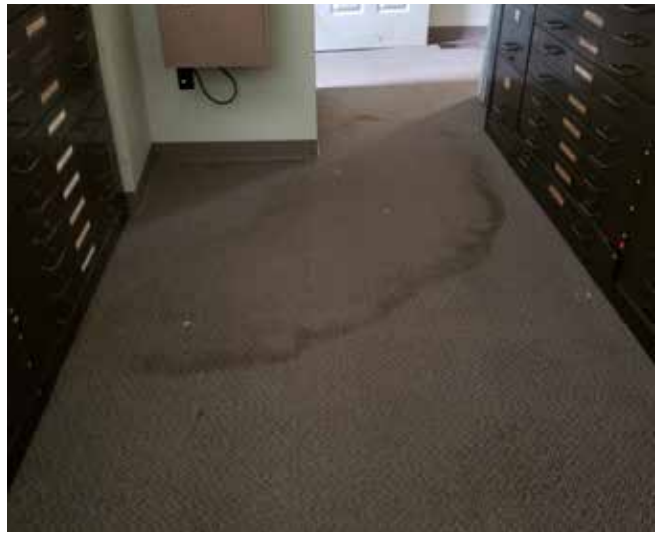
20. Planning Office wet carpet damage

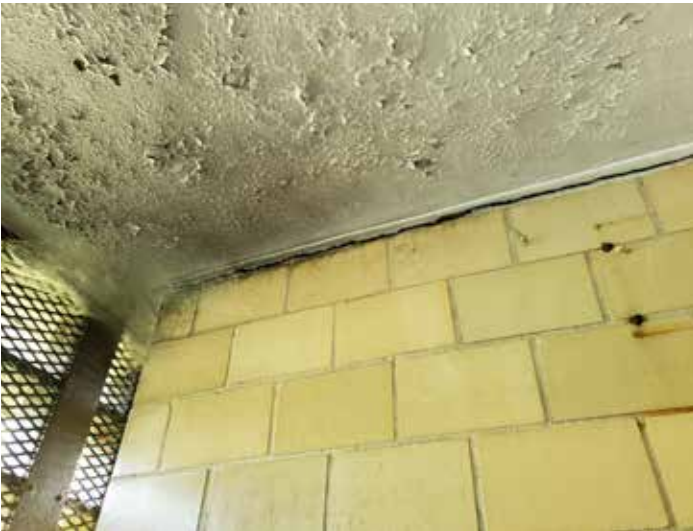
21. Mt. Echo CS ceiling damage

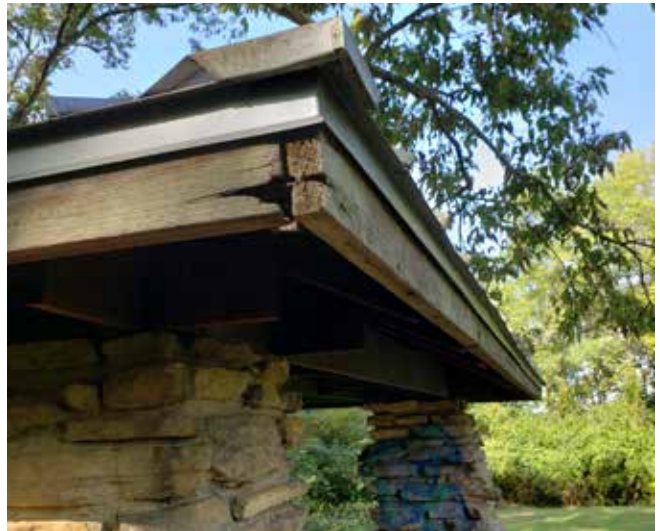
22. Mt. Echo shelter roof damage

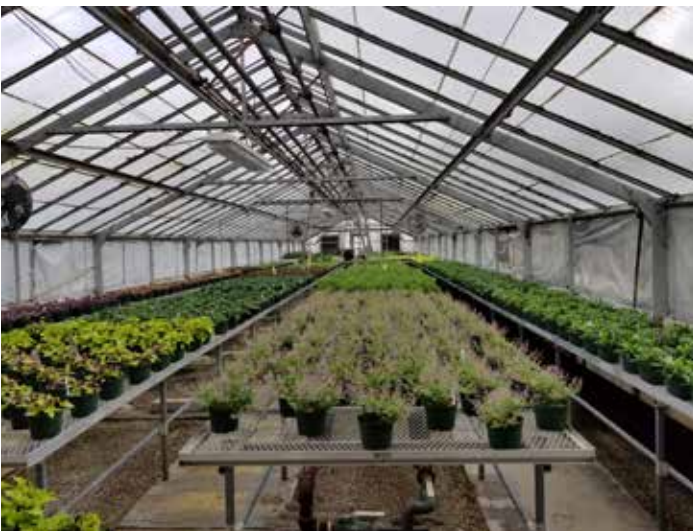
23. Warder Greenhouse single pane glass

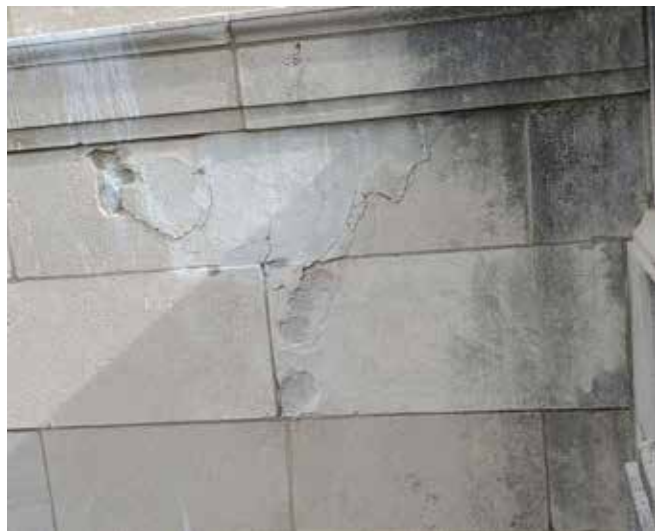
24. Ault Cascade delaminating sandstone

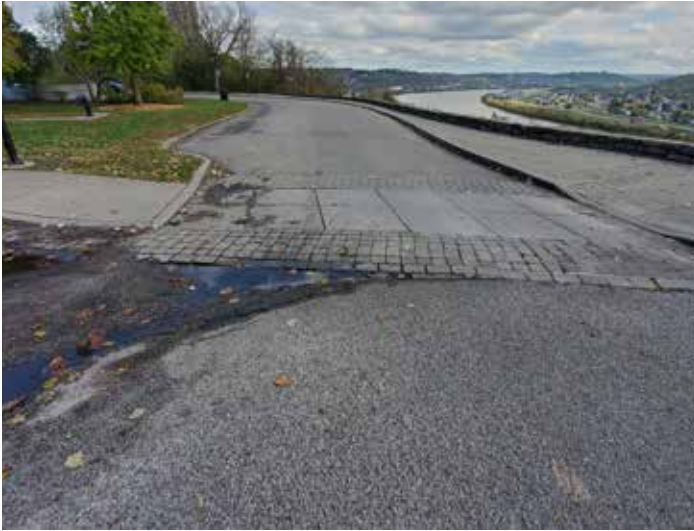
1. Eden Twin Lakes crosswalk pavers

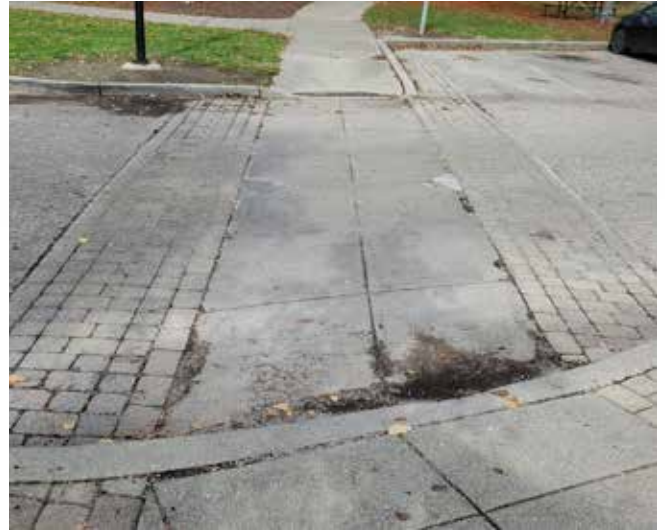
2. Eden Twin Lakes crosswalk

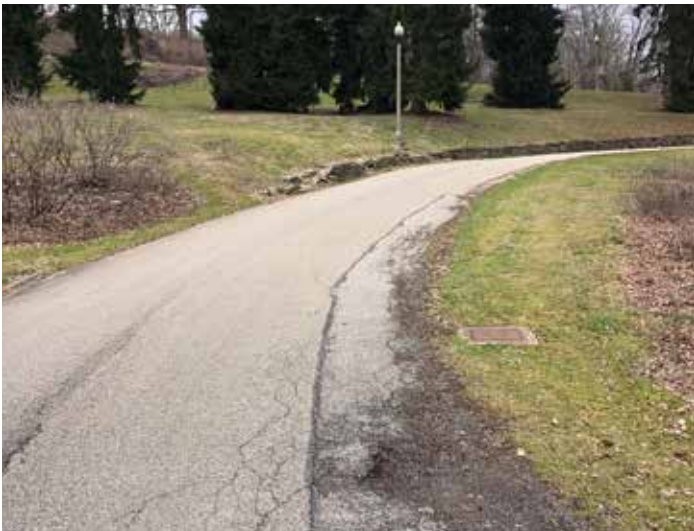
3. Alms Park deteriorating pavement

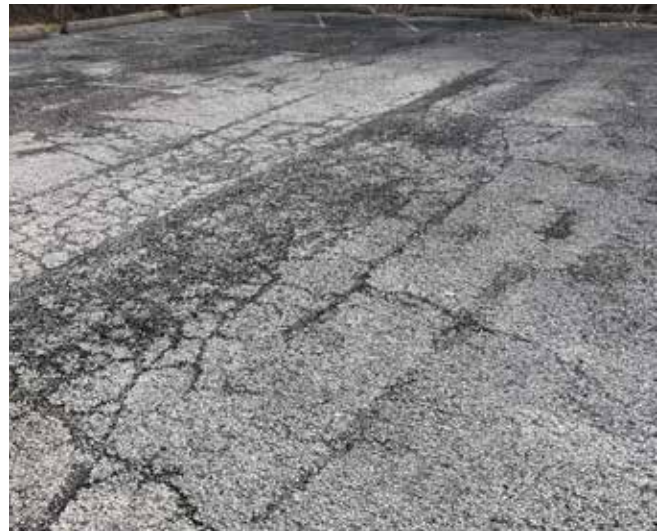
4. Avon Woods pavement

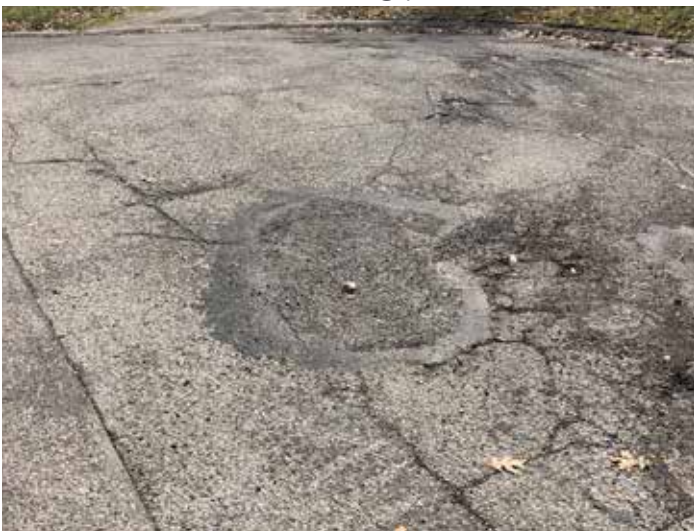
5. Mt. Echo poor pavement

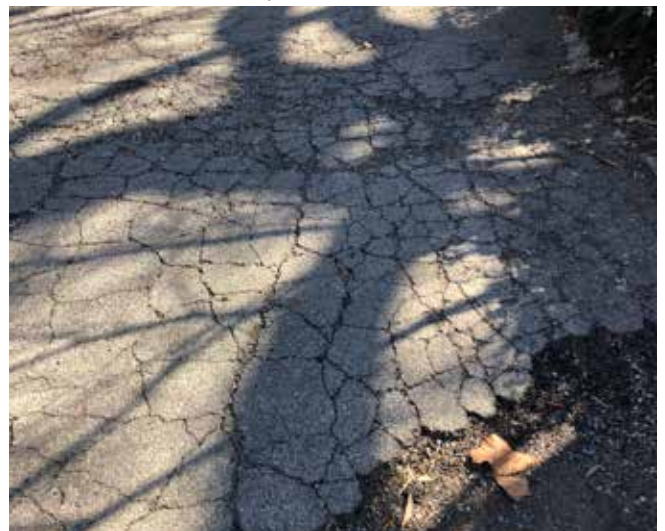
6. Hauck Gardens deteriorated pavement

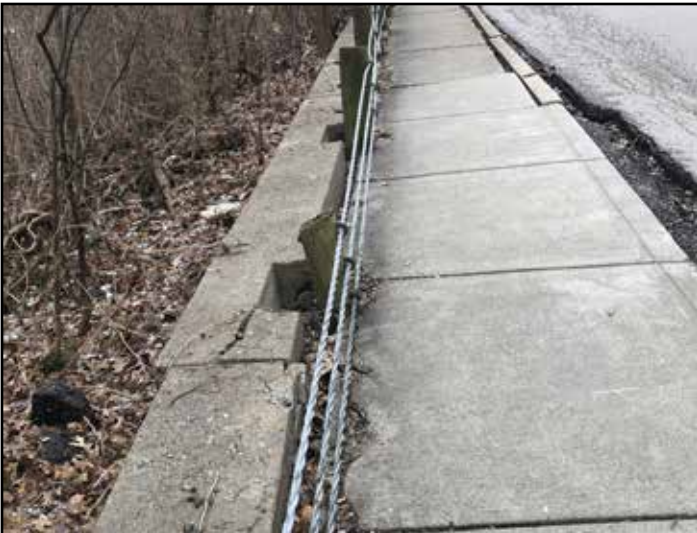
7. Wall, walk, and paving at Eden Park

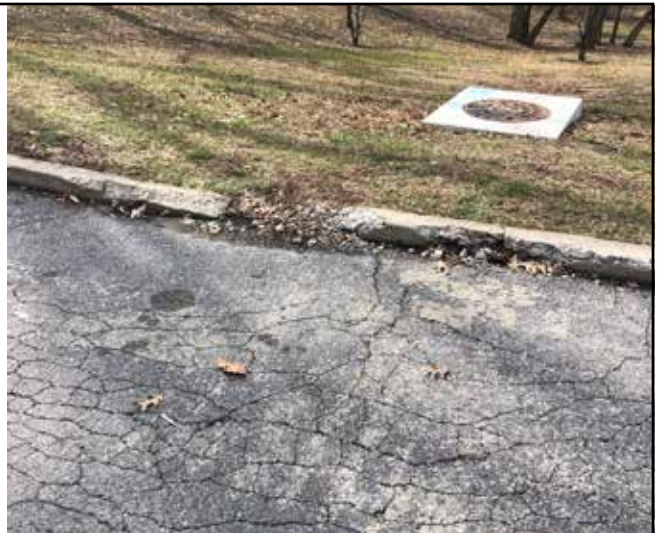
8. Eden Park damaged curb

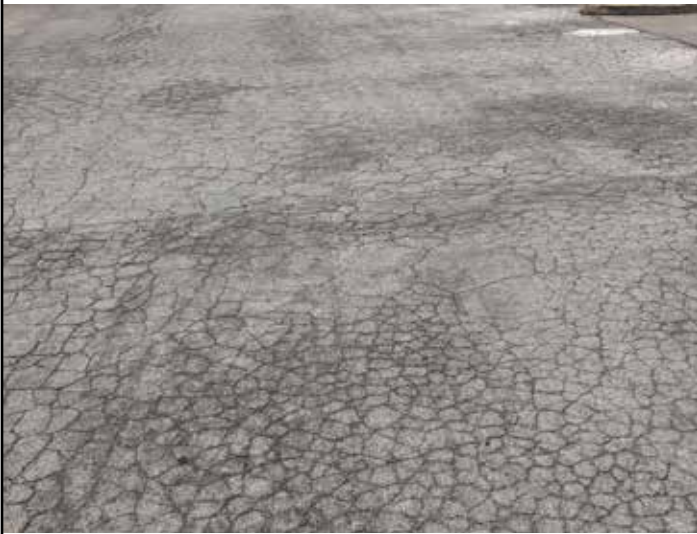
9. Sawyer Point deteriorated asphalt

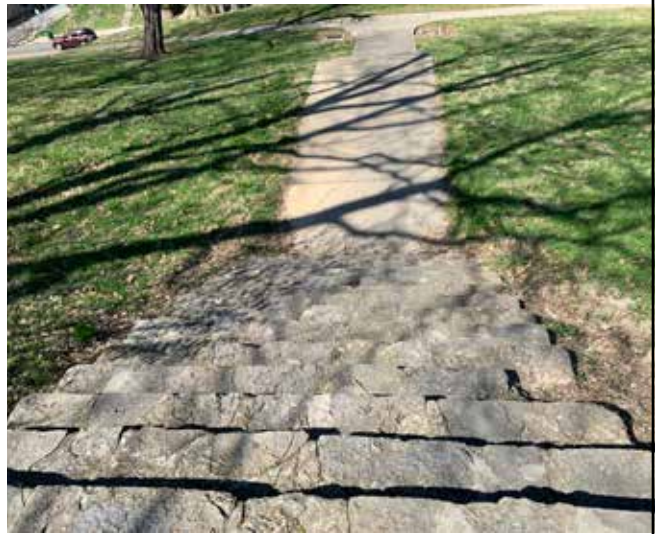
10. Glenway Park stairs with no railing

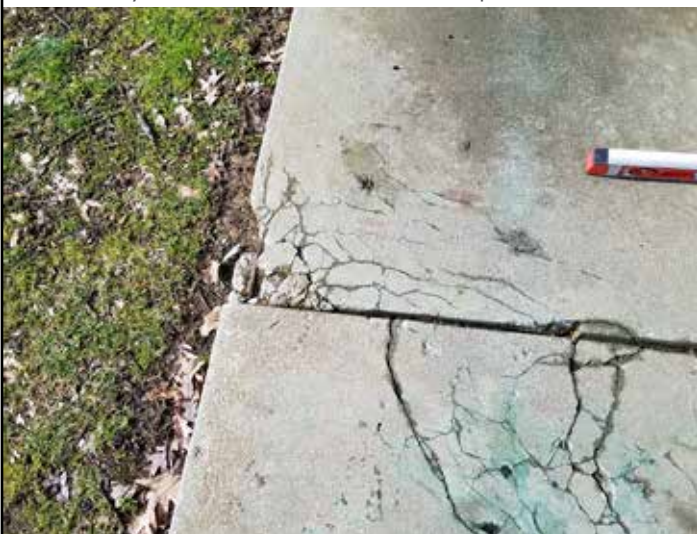
11. French Park cracked sidewalks

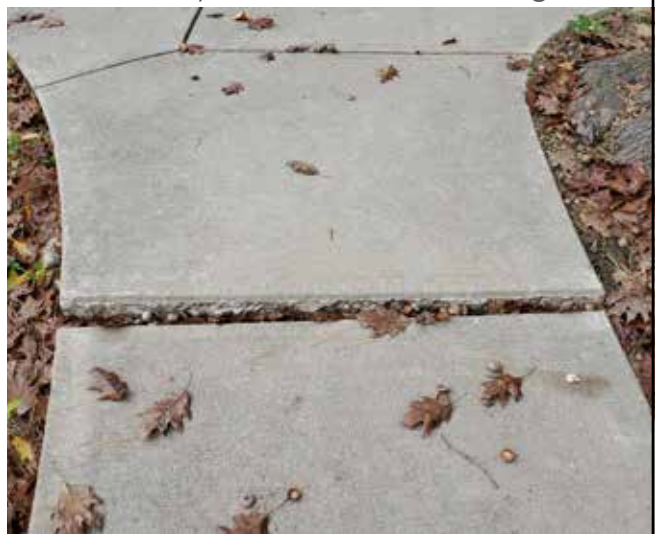
12. Kennedy Heights uneven sidewalk

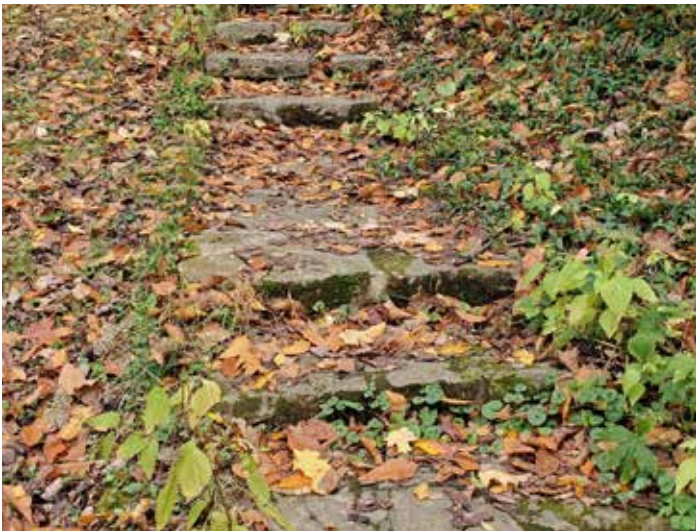
13. Kennedy Heights steps with no railing

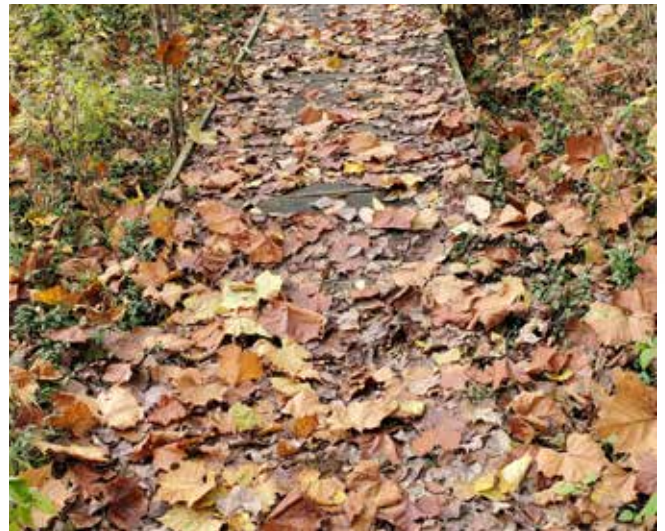
14. Kennedy Heights shaky footbridge

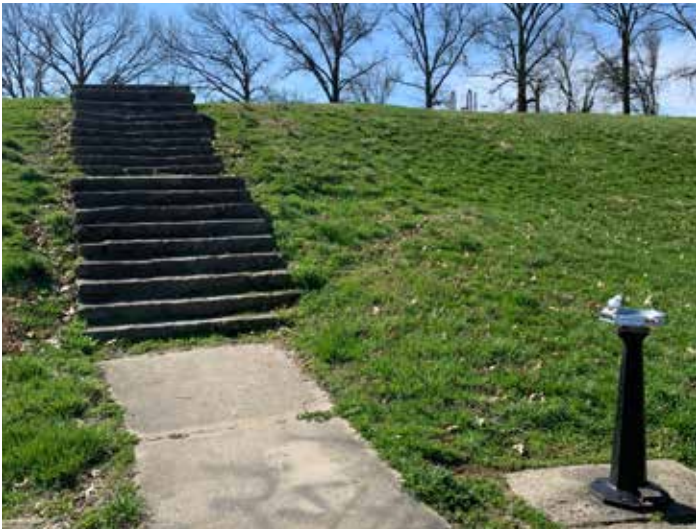
15. Mayfield steps with no handrails

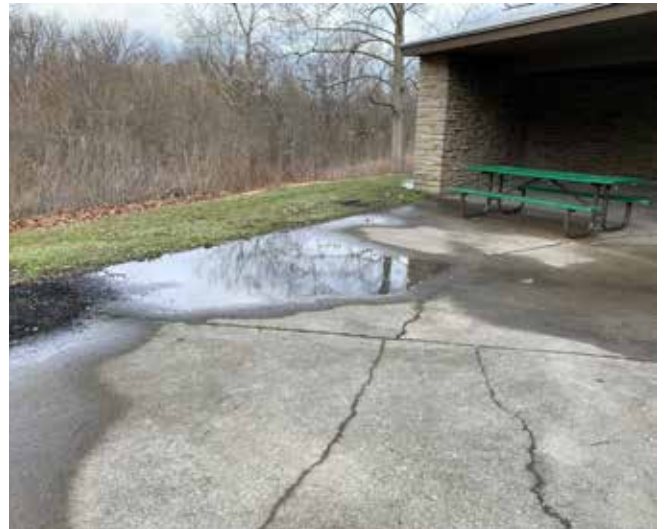
16. McEvoy cracked concrete

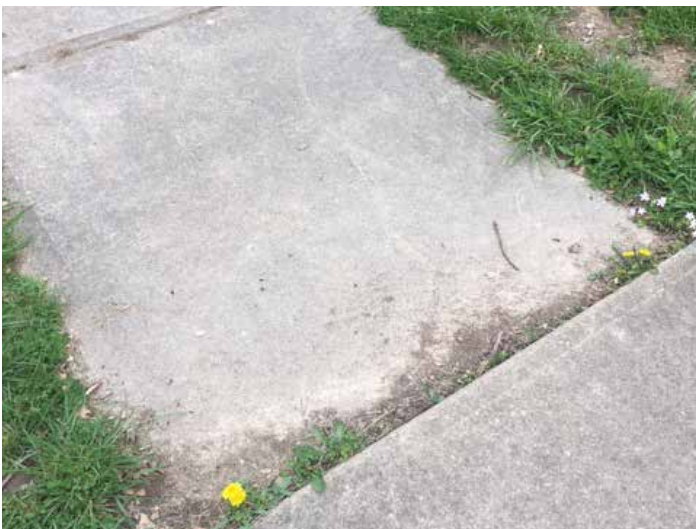
17. Mt. Airy Area 13 uneven sidewalks

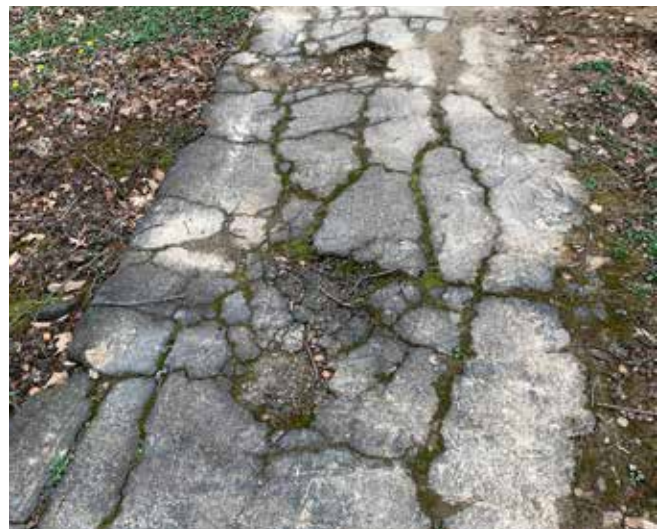
18. Arboretum damaged sidewalk

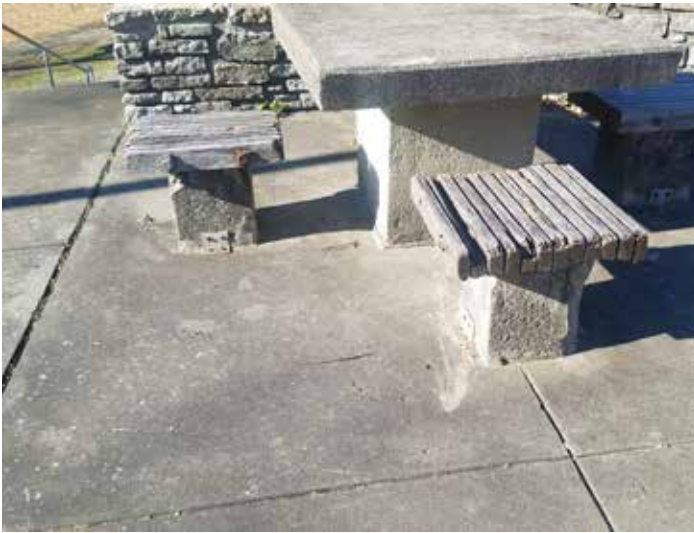
1. Inwood tables

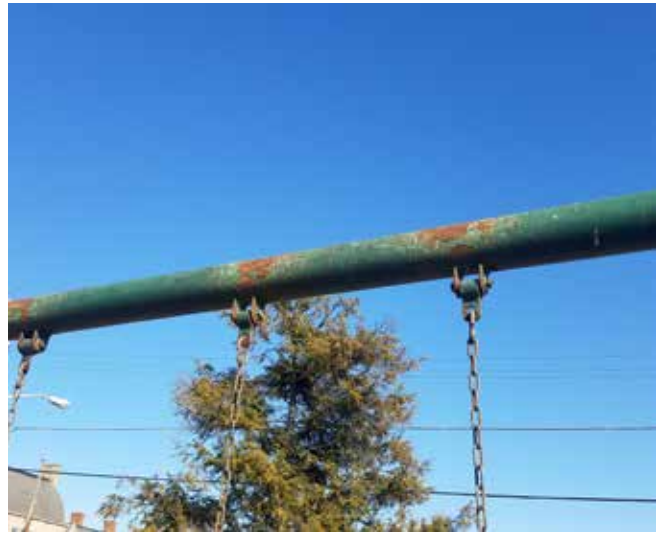
2. Jackson Hill rusted swings

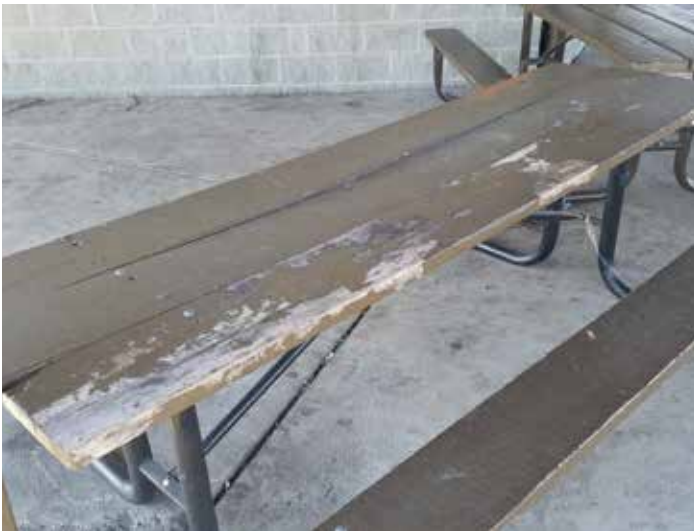
3. Jackson Hill worn picnic tables

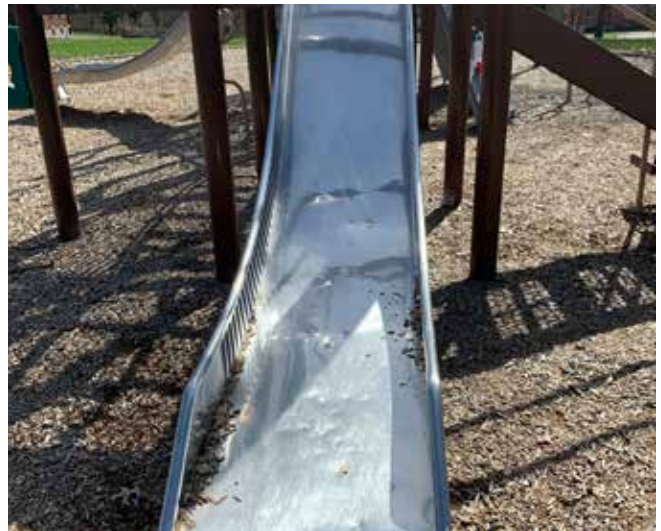
4. Mayfield dented slides

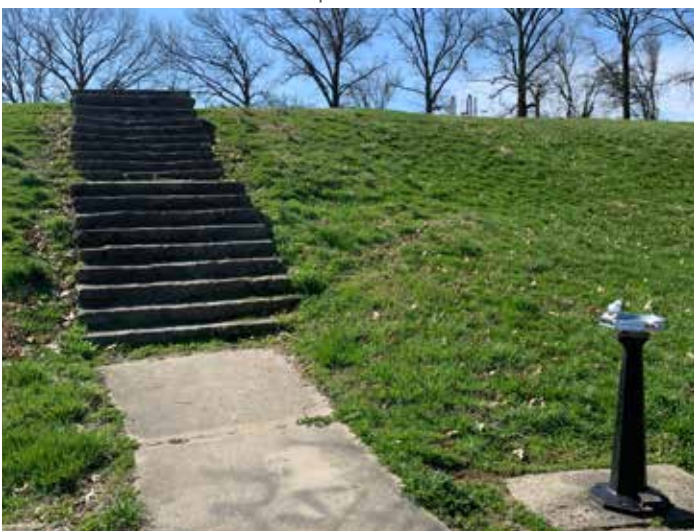
5. Mayfield inaccessible drinking fountain

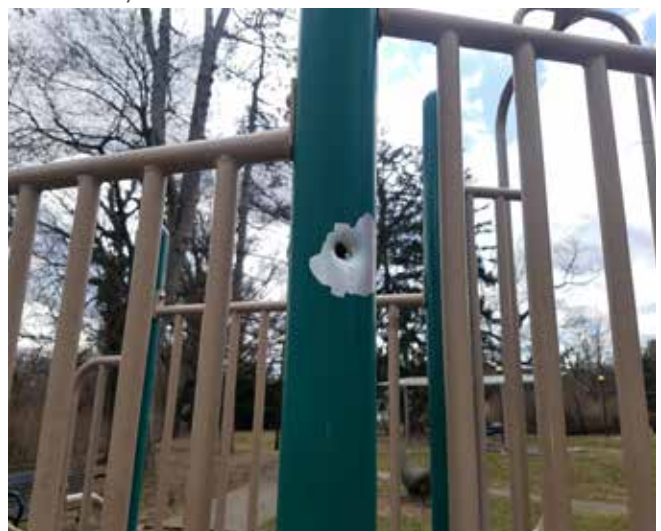
6. Stella Park damaged playground

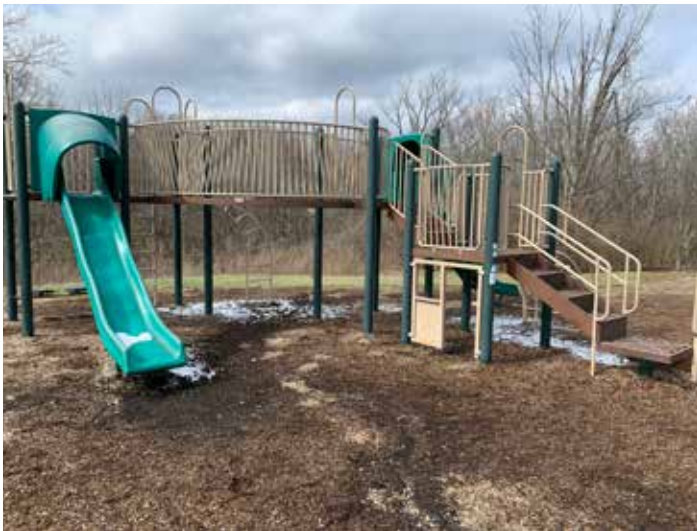
7. McEvoy uneven safety surface

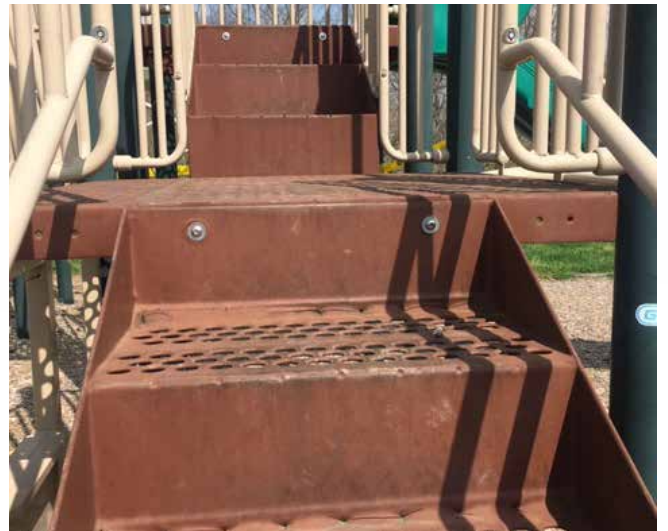
8. Maple Ridge worn play equipment

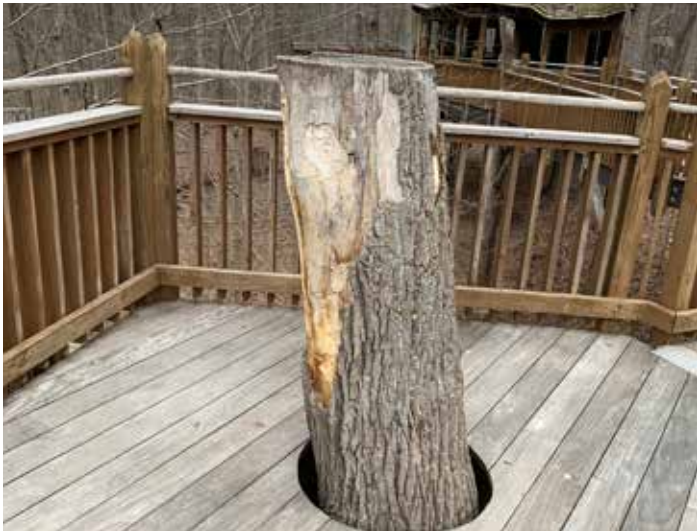
9. Mt. Airy Treehouse dead tree

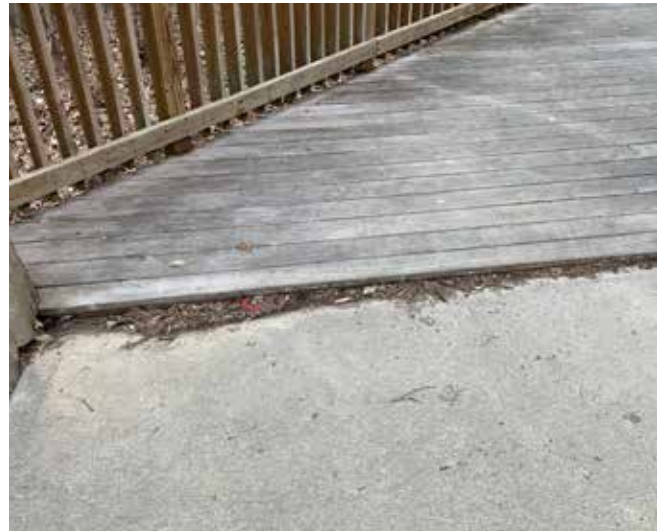
10. Mt. Airy Treehouse uneven surfaces

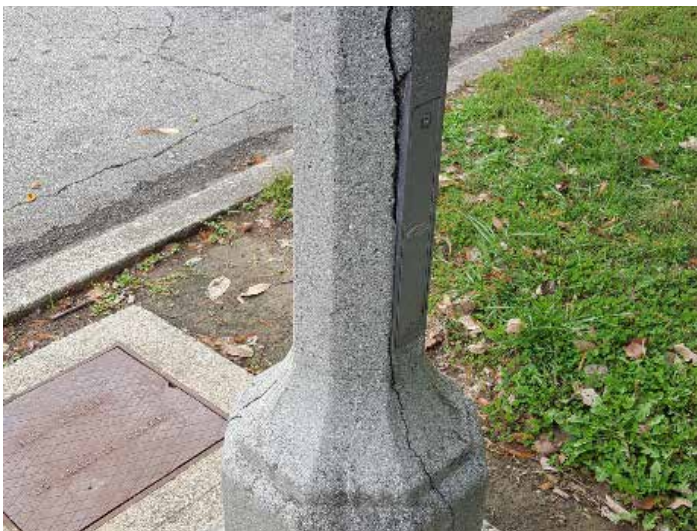
11. Cracked light post at Alms Park

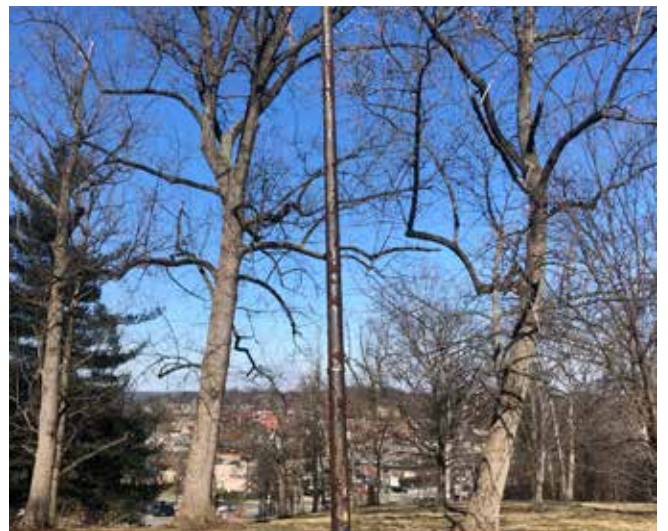
12. Rusted light post at Burnet Woods
