Galbraith Road Bridge

2021

BRIDGE CONDITION REPORT

City, County, Railroad and Private Bridges

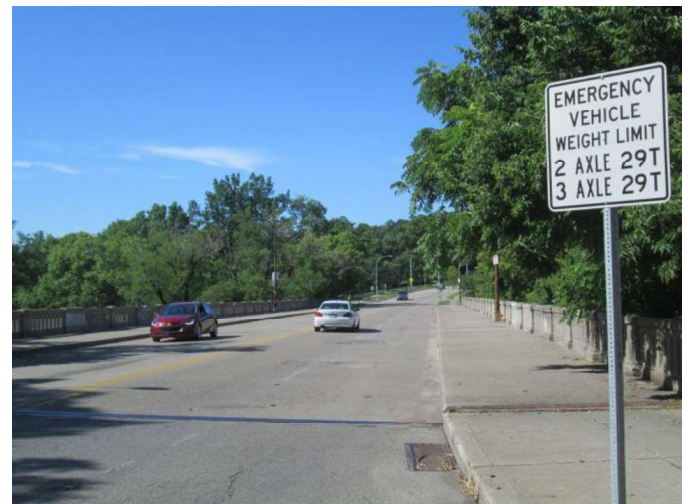
Above: Park Avenue Bridge over Kemper Lane with Load Posting sign for Emergency Vehicles.

partial rehabilitation of the Park Ave Bridge over Kemper Lane, which will be available in 2025. The project includes specific repairs which will strengthen the bridge and eliminate the need for the load restrictions.

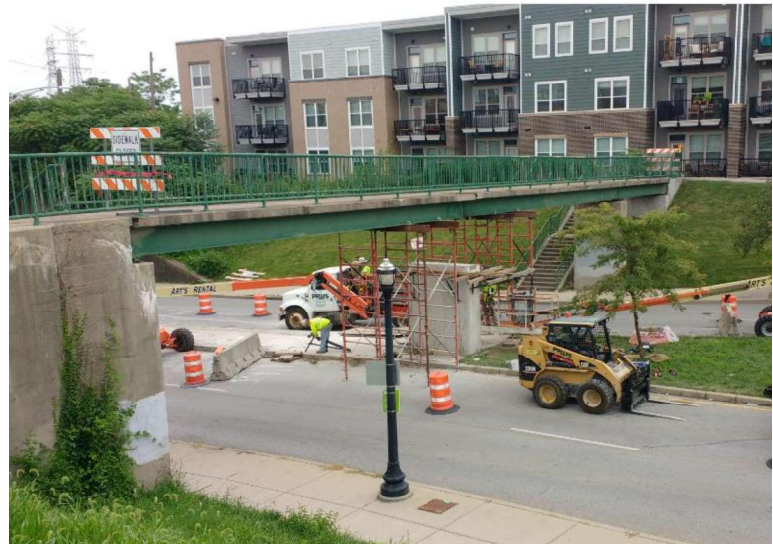
1. The condition rating of the **Madison Road Pedestrian Bridge West of IORY SFN 3161889** was increased from 5 (fair condition) to 7 (good condition), as a result of the 2020/2021 bridge rehabilitation.
2. The condition rating of the **Second Street Connector from Clay Wade Bailey (ramp D), SFN 3160661** was reduced from 8 (very good condition) to 7 (good condition), due to the condition of the substructure.
3. The condition rating of the **Second Street over Transit Center – Elm to Main Street, SFN 3160696** was reduced from 8 (very good condition) to 7 (good condition) due to the condition of the substructure.
4. *The condition rating of the **Van Hart Street Bridge over Lick Run, SFN 3160005** was reduced from 8 (very good condition) to 7 (good condition) due to the condition of the superstructure beams.

Madison Road Pedestrian overpass west of IORY, during construction (above 2020) and after completion (below 2021)

This project consisted of the superstructure replacement of one of two existing 60-year-old pedestrian bridges over Madison Road. to address deterioration and accommodate an Oakley community “gateway” project, and rehab work on the second structure. The project was funded primarily by a combination of TIF and other economic development funds with a cost of \$1.7M. The ribbon cutting for the eastern pedestrian bridge with the new gateway feature was in December 2020, and the finishing touches were applied to both bridges in spring 2021.

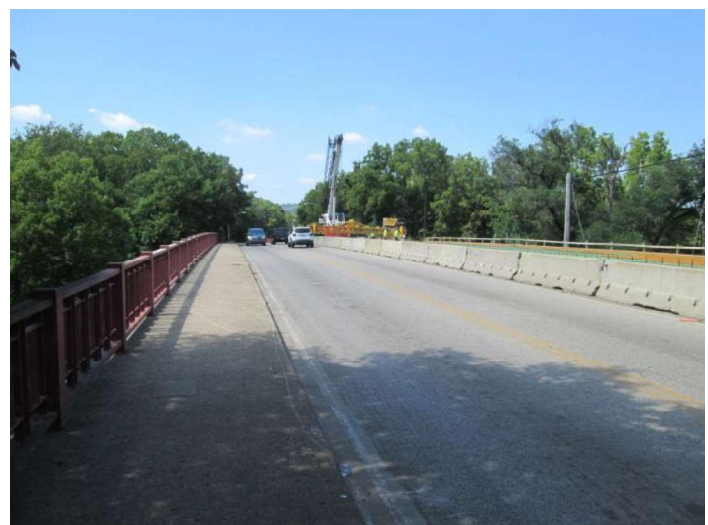
Ongoing part-width construction work at the Galbraith Ave Bridge over Anthony Wayne and RR

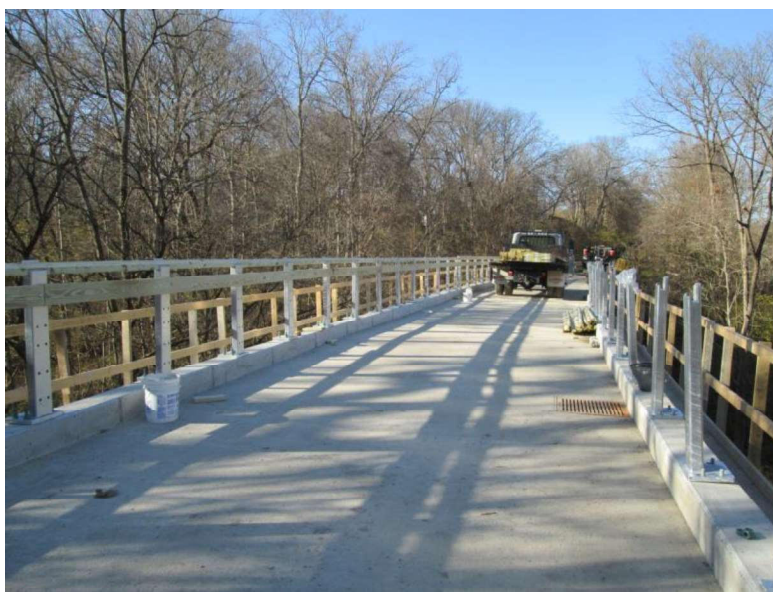
- 1) The condition of the **Wasson Way Bridge over Ault Park, SFN 3199931** was increased from 3 (serious condition) to 5 (fair condition) as a result of the rehab work that began in the summer of 2020. This bridge rehabilitation project is still ongoing and a further increase in condition is expected as a result of the remaining work. Any change in condition will be reported as part of the 2022 inspection.

Railing installation at the Wasson Way Bridge over Ault Park

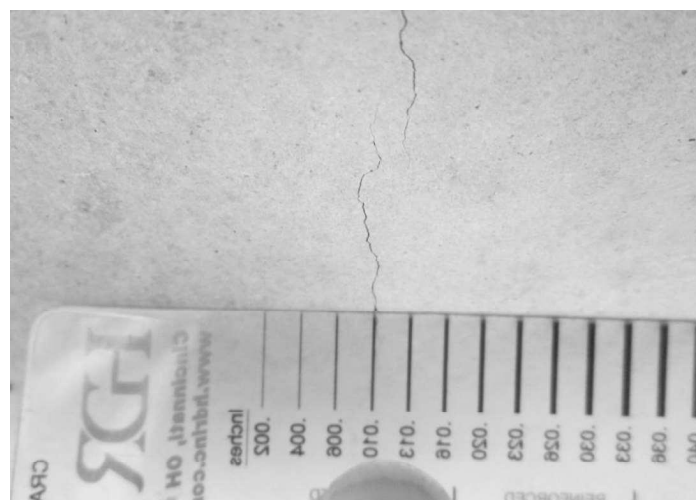
The rating guidelines for prestressed concrete box beams became stricter as well. The revised rating guidelines require lower condition ratings for prestressed box beams with concrete cracking, regardless of the crack width or associated leakage, which primarily affects bridges in the satisfactory to very good condition range (ratings 6 to 8). This is likely due to ODOT's experience with a large inventory of prestressed box beam bridges showing evidence that early cracking can be indicative of the onset of prestressing strand corrosion. Unlike expansion joints, the condition ratings of prestressed box beams alone will control the summary rating of the deck and superstructure, and likely control the overall rating of a bridge, and therefore these new guidelines have resulted in lower overall ratings for some bridges in the City inventory. These types of beams are typically used for short span structures and there are a total of 22 bridges with these types of beams in the City inventory: 10 City (BP), 7 County, and 5 FWW bridges. The City began implementing the stricter rating guidelines on July 1, 2021. Six bridges with these types of beams were inspected after that date and assigned a lower overall rating due to the new guidelines. These include the Van Hart bridge over Lick Run (City (BP)), Kennedy Avenue Bridge over IORY, Harrison Avenue Bridge over Lick Run (both County), and Race Street, Vine Street and Walnut Street Bridges over FWW. The remaining bridges of this type either were not affected by the new guidelines or had already been inspected prior to July 1, 2021 and will be evaluated using the stricter guidelines during the 2022 inspection cycle.

Above: monitoring cracking in prestressed concrete box beams, here van Hart bridge over Lick Run

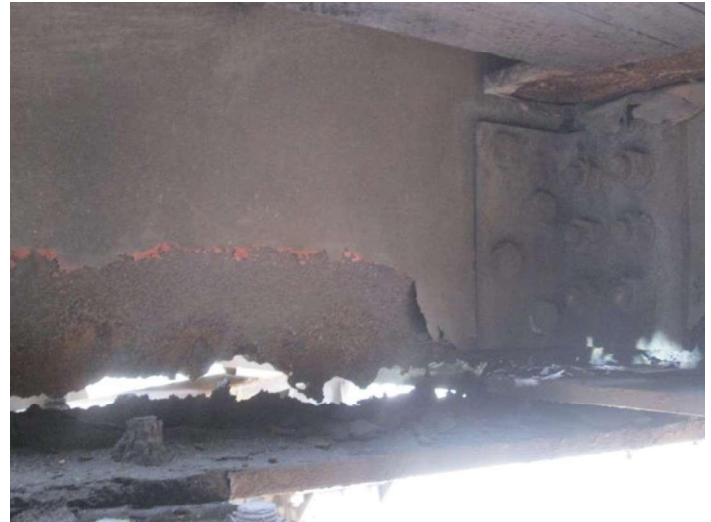
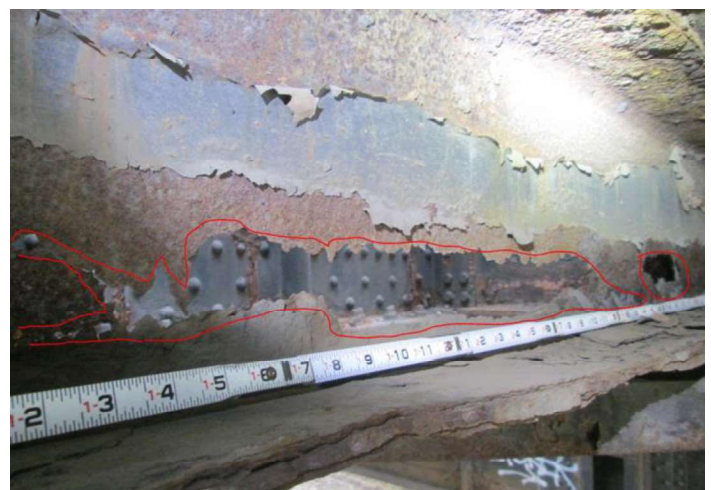
The third one is the *Gest Street Chessie Overhead – 1st East of Mill Creek* which is owned and maintained by CSX. The condition of the floorbeams and stringers, which are rusted completely through in many places, is controlling the rating. A special close-up investigation for the most concerning members of this bridge was performed in September 2021 by DOTE and the results have been brought to the attention of CSX.

Above: Perforated floorbeams under the Gest Street Chessie overhead – 1st East of the Mill Creek.

Below: perforated stringer on the same bridge

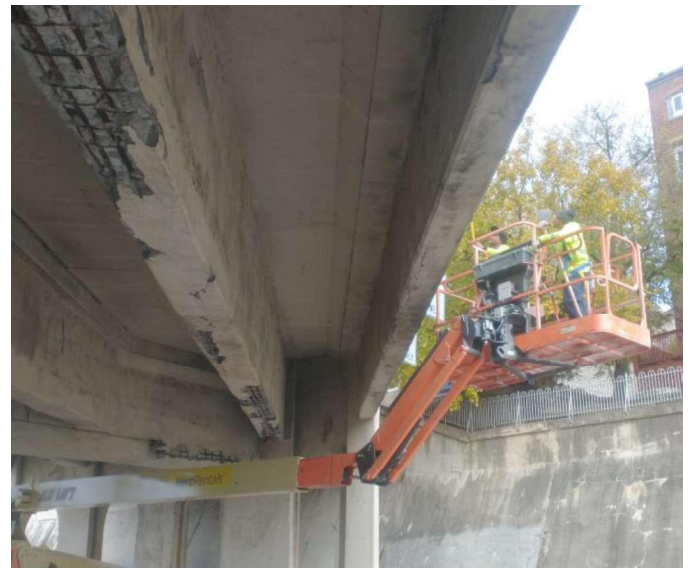
Removal of delaminated concrete from the Brighton Street Bridge over Central Parkway.

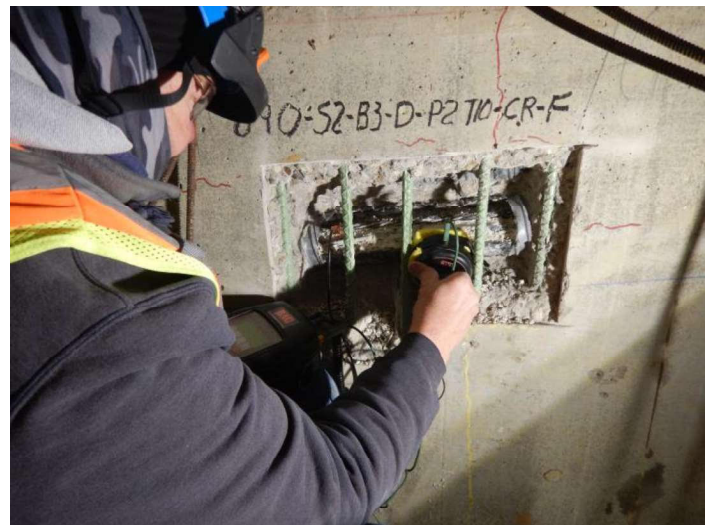
Above: PT investigation at 2nd Street.

A city directed consultant performed an in-depth inspection of the condition of the post tensioning systems in the Second Street bridges over the transit center and the east approach to the transit center and provided recommendations for further investigations and repairs. Post tensioning systems are critical to structures but cannot be inspected with typical non-destructive methods. ODOT’s nearby bridges of a similar type and built around the same time period as part of the Fort Washington Way reconstruction project were recently investigated and found to be in need of repair. The investigation of the Second Street bridges was funded with City bridge program capital funds at a cost of approximately \$450,000. Field investigations were performed in fall 2021, followed by lab testing and issuance of the report in summer 2022.

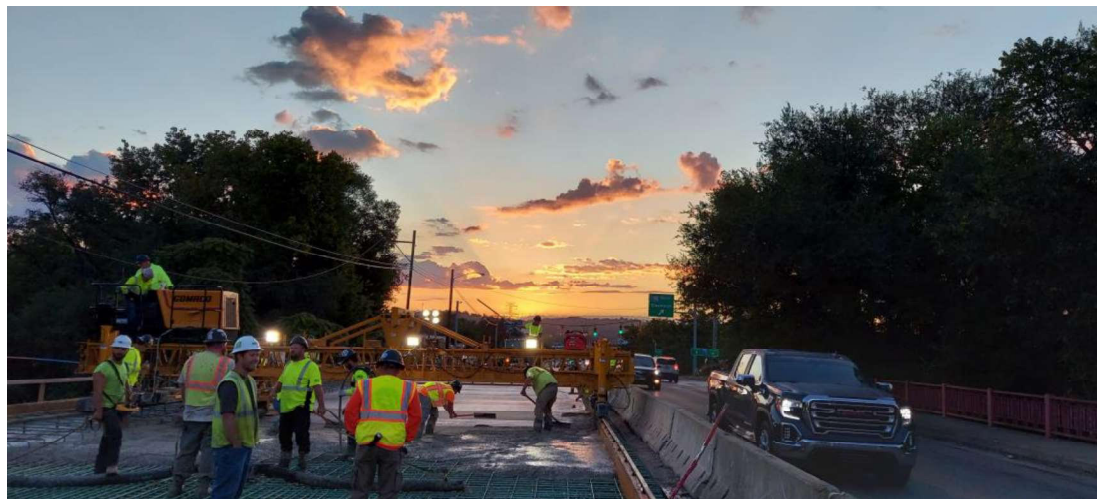
Left: Deck pour on the Galbraith Rd bridge over Anthony Wayne and RR

This project replaces the deck, sidewalks and railings of the 70-year-old structure. Outside funding in the amount of \$2.64M was secured to cover a portion of the total \$5.73M project. Construction began in 2020 and will be completed in two phases in order to maintain traffic on the bridge. Construction is currently scheduled to be completed in late 2022.

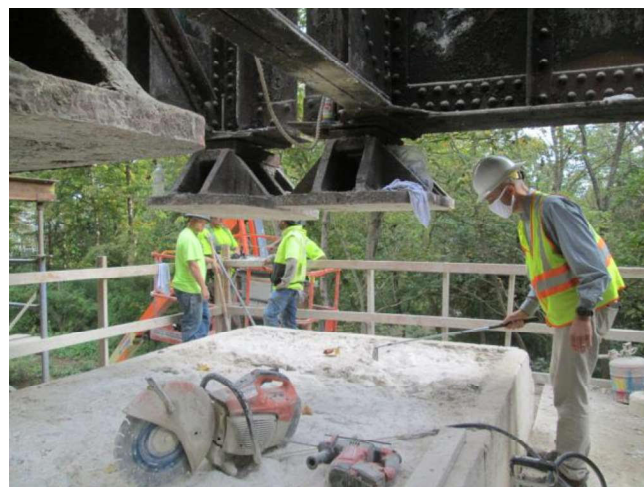
Above: 2021 Pier cap reconstruction at the Wasson Way Bridge over Ault Park.

Wasson Way over Ault Park – Bridge Rehabilitation (Wasson Way Bridge in Mt Lookout). As part of phase 5 of the Wasson Way project, the 97-year-old former railroad bridge will be transformed into a trail bridge. The bridge was opened to trail traffic in December 2021, with painting and minor steel repair work following in 2022. The estimated cost for this project is \$1.2M and will be paid for with a combination of Wasson Way funds and STP grant funds.

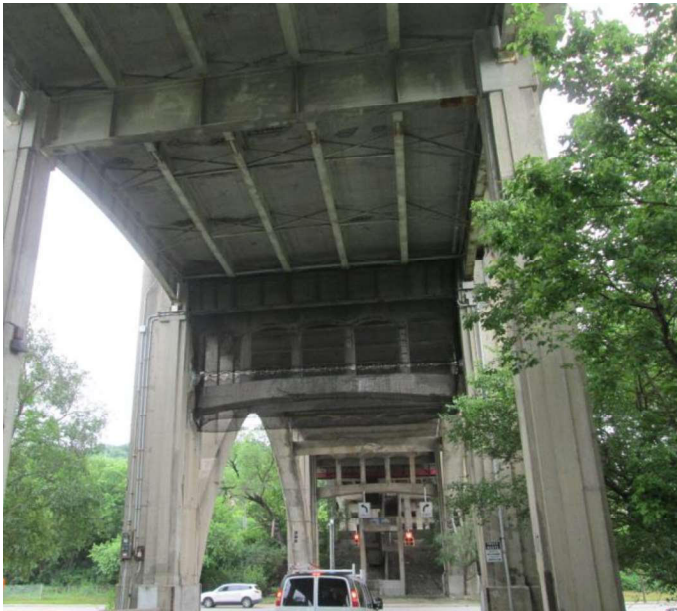
The existing viaduct is rated in poor condition (condition rating of 4). It is structurally deficient due to advanced and widespread deterioration of numerous members, is posted for weight limits, and is also functionally obsolete, meaning it does not meet current roadway geometric standards. At locations where the deterioration is at its worst, supplemental supports have been added beneath the bridge to avoid a partial closure, which would restrict traffic from the lower deck. Spalling concrete falling from the upper deck to the lower deck is a continual safety problem which is being routinely addressed by installation of netting at a critical area and regular closures of the lower deck in order to remove loose and delaminated concrete.

Debris netting under the Western Hills Viaduct west of Spring Grove Avenue
