INFRASTRUCTURE MANAGEMENT AND ENGINEERING

RESULTS OF PAVEMENT CONDITION 2019 SURVEY

FINAL REPORT

May 2020

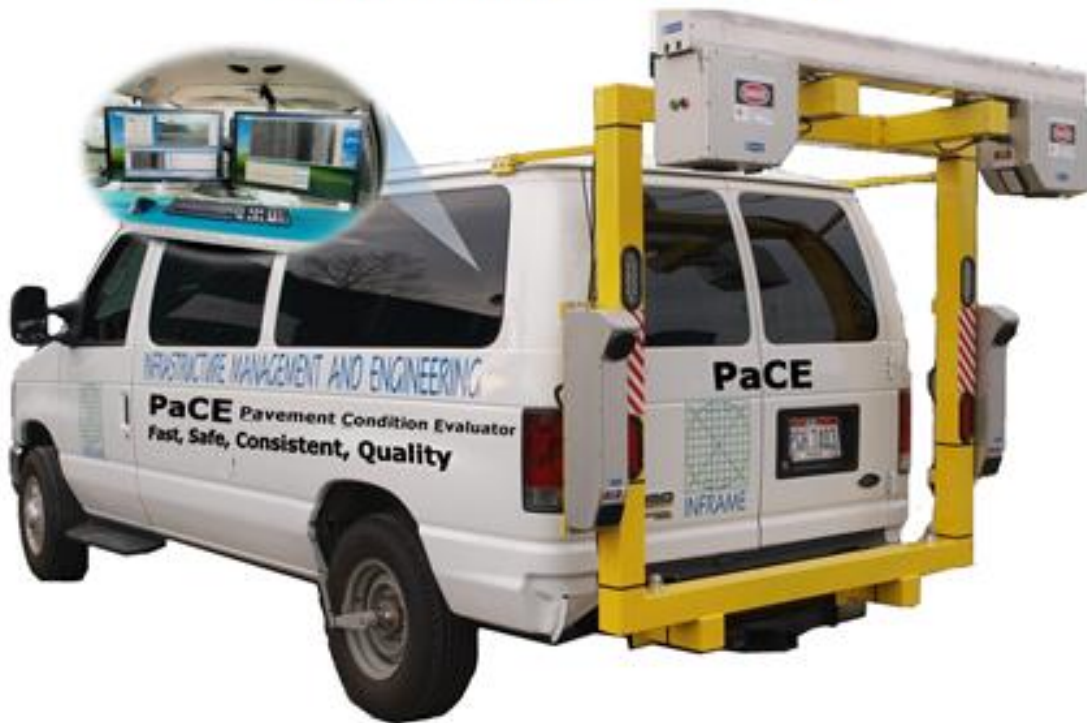
Figure 1 Pavement Condition Evaluator, PaCE

INFRAME uses its Pavement Condition Evaluator (PaCE) vehicle for pavement data collection. PaCE has four high resolution line scan cameras, four high powered lasers, high definition camcorder, GPS and Distance Measuring Instrument. This vehicle scans full lane width of pavements and captures distresses such as cracking, raveling, pothole, rutting etc. A high-definition camcorder onboard the vehicle is used for Pavement Right-of-Way (ROW) image acquisition. A GPS unit provides highly accurate geo-reference for all images. The PaCE vehicle will enable the engineers to conduct a full lane width distress survey at speeds of up to 60 mph. The system is extremely versatile and delivers data in multiple formats as desired by users. In summary, INFRAME's pavement condition services will result in the following:

Figures 1 to 3 show a view of the PaCE vehicle and its components.

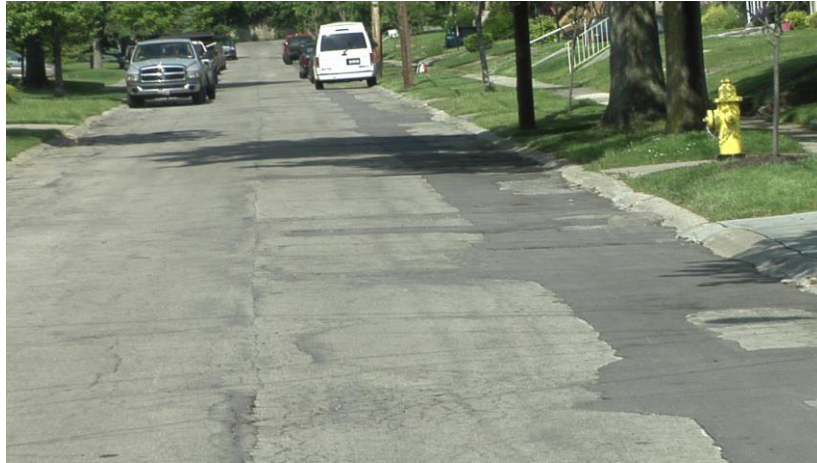
Figure 4 ROW Image Acquisition

Figure 4 shows typical Right-of-Way (ROW) image collected by the system while collecting the pavement condition data.

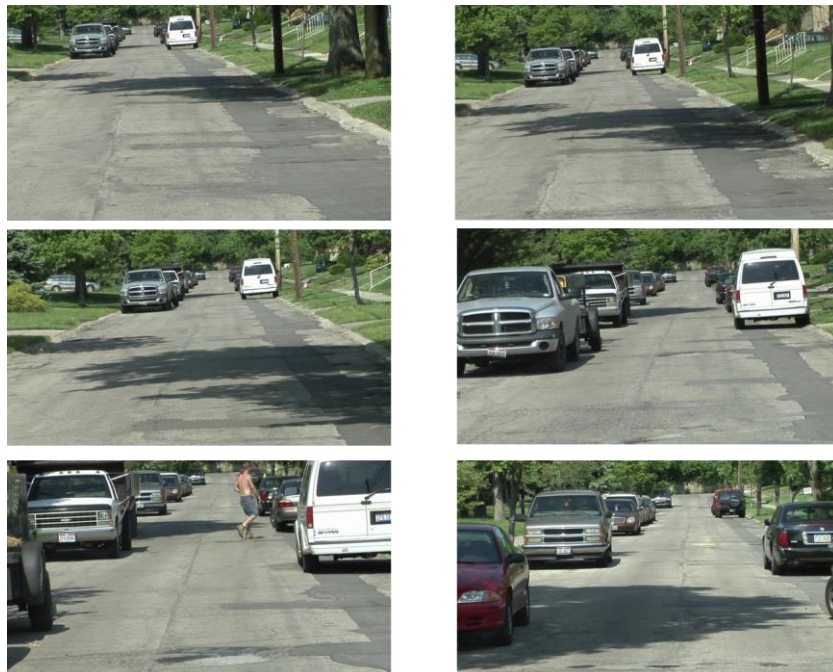
Figure 5 Sequences of ROW Images

Such images are acquired continuously while the PaCE vehicle is driven over the street pavements. Figure 5 illustrates sequences of images acquired. These images are saved onto a hard drive for processing at a later stage.

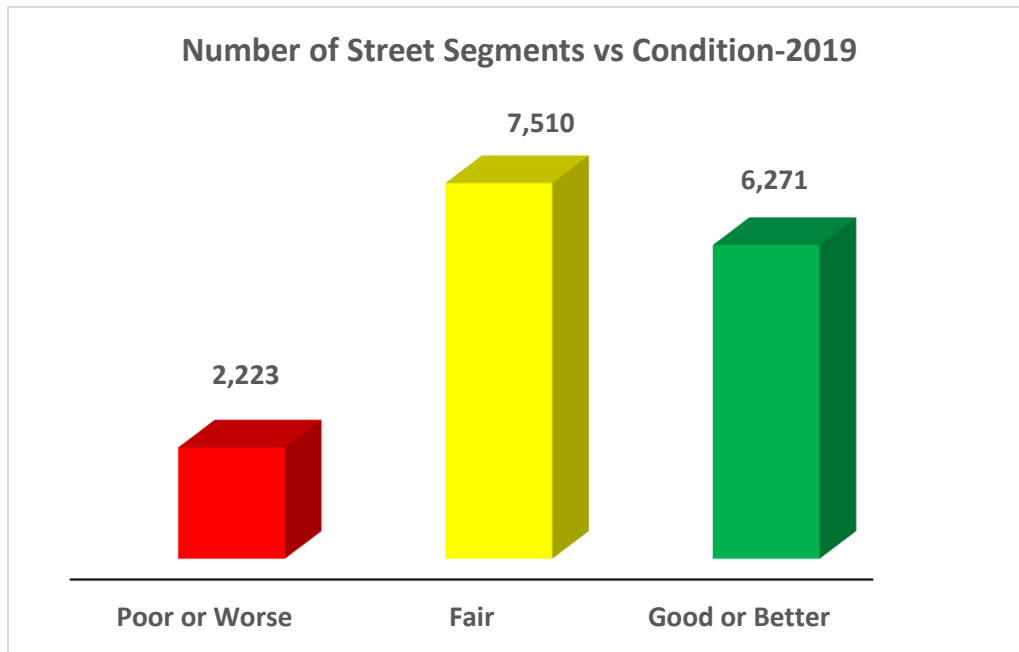
Figure 7 Number of Cincinnati’s Street Segments in Various Condition Categories

Figure 7 shows number of street segments in each pavement condition from poor to excellent; Figure 8 shows the same information as percentage of total number of street segments. These graphs help the city administrators to quickly grasp the general health of city's street network. Figure 9 shows a comparison between 2018 and 2019 data.

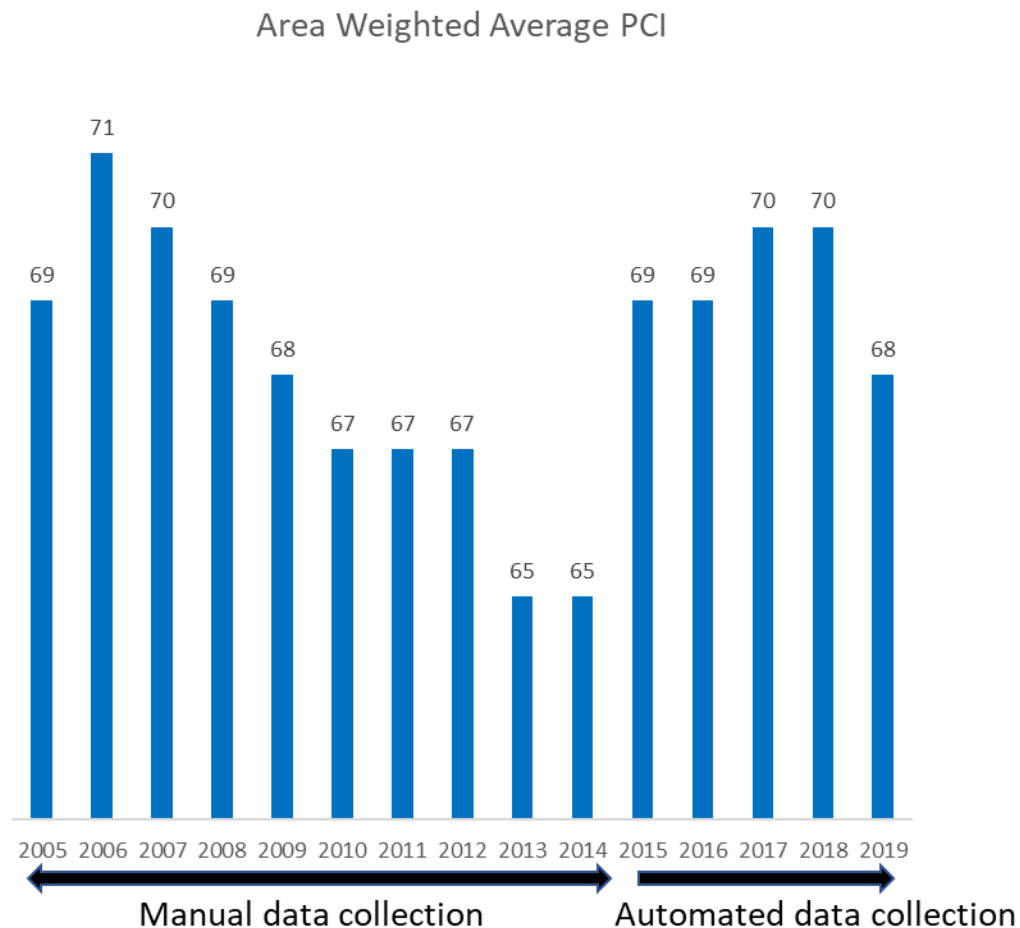
Figure 14 Cincinnati's Network PCI Average 2005 to 2019

Until the end of 2014, the City was using a "manual" data collection system, which tended to provide more subjective results. The automated data collection process began in 2015. The automated system results in collection of a large amount of data which also provides more consistent, reliable results. So, the 2015 PCI of 69 simply reflects an adjustment to the PCI's reported previously - not an increase of four points in the span of only one year - and provides a good benchmark for comparisons to the average PCI's measured in the future years. Since the first year of automated data collection, the average PCI for the City's street network has held steady or increased slightly, showing that the increased funding for Street Rehabilitation and Preventive Maintenance has indeed been beneficial to the network's overall condition.
