Galbraith Road Bridge

2021

BRIDGE CONDITION REPORT

City, County, Railroad and Private Bridges

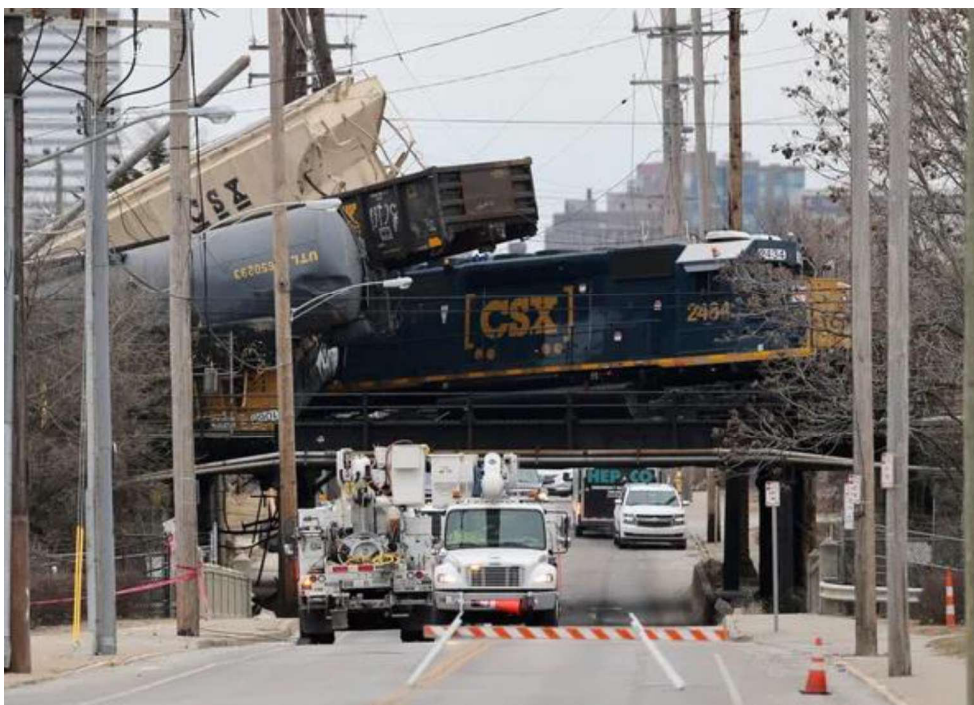
Cincinnati Enquirer
Picture: Derailment of
CSX train at Gest
Street overpass,
January 2021

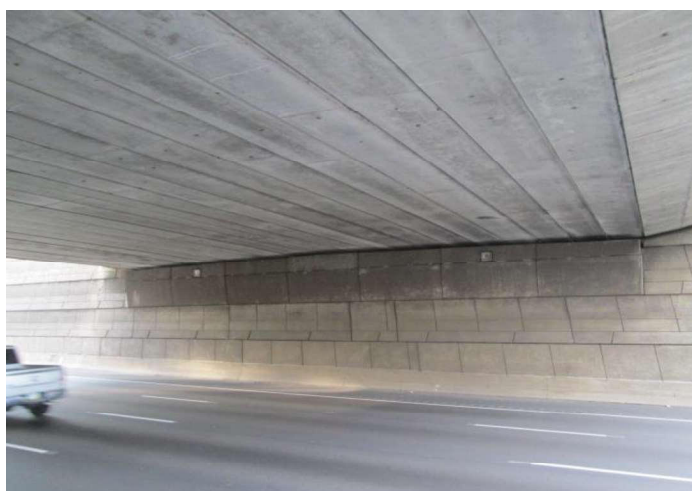
The rating guidelines for prestressed concrete box beams became stricter as well. The revised rating guidelines require lower condition ratings for prestressed box beams with concrete cracking, regardless of the crack width or associated leakage, which primarily affects bridges in the satisfactory to very good condition range (ratings 6 to 8). This is likely due to ODOT's experience with a large inventory of prestressed box beam bridges showing evidence that early cracking can be indicative of the onset of prestressing strand corrosion. Unlike expansion joints, the condition ratings of prestressed box beams alone will control the summary rating of the deck and superstructure, and likely control the overall rating of a bridge, and therefore these new guidelines have resulted in lower overall ratings for some bridges in the City inventory. These types of beams are typically used for short span structures and there are a total of 22 bridges with these types of beams in the City inventory: 10 City (BP), 7 County, and 5 FWW bridges. The City began implementing the stricter rating guidelines on July 1, 2021. Six bridges with these types of beams were inspected after that date and assigned a lower overall rating due to the new guidelines. These include the Van Hart bridge over Lick Run (City (BP)), Kennedy Avenue Bridge over IORY, Harrison Avenue Bridge over Lick Run (both County), and Race Street, Vine Street and Walnut Street Bridges over FWW. The remaining bridges of this type either were not affected by the new guidelines or had already been inspected prior to July 1, 2021 and will be evaluated using the stricter guidelines during the 2022 inspection cycle.

Above: underside of prestressed box beam bridge at Race Street over FWW

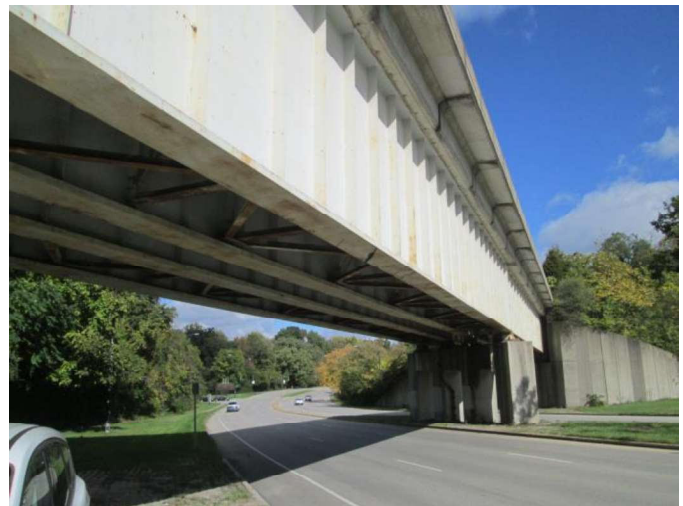
Wasson Way over Victory Park Way (RR bridge in Evanston). As part of phase 6 of the Wasson Way project, one of the two parallel abandoned 48-year-old railroad bridges will be transformed into a trail bridge. This bridge is not part of the original Wasson Way corridor that was purchased from Norfolk Southern in 2016, but is instead owned by SORTA and will be utilized by the Wasson Way trail by agreement. Plans for the bridge rehabilitation are currently being developed by DOTE staff. Construction is estimated to begin in late 2023.

Above: abandoned RR bridge over Victory Parkway
