Geotechnical Engineering Report

**Walworth Avenue Development
Cincinnati, Hamilton County, Ohio**

Terracon Project No. N1195144

East End Developers LLC
Cincinnati, Ohio

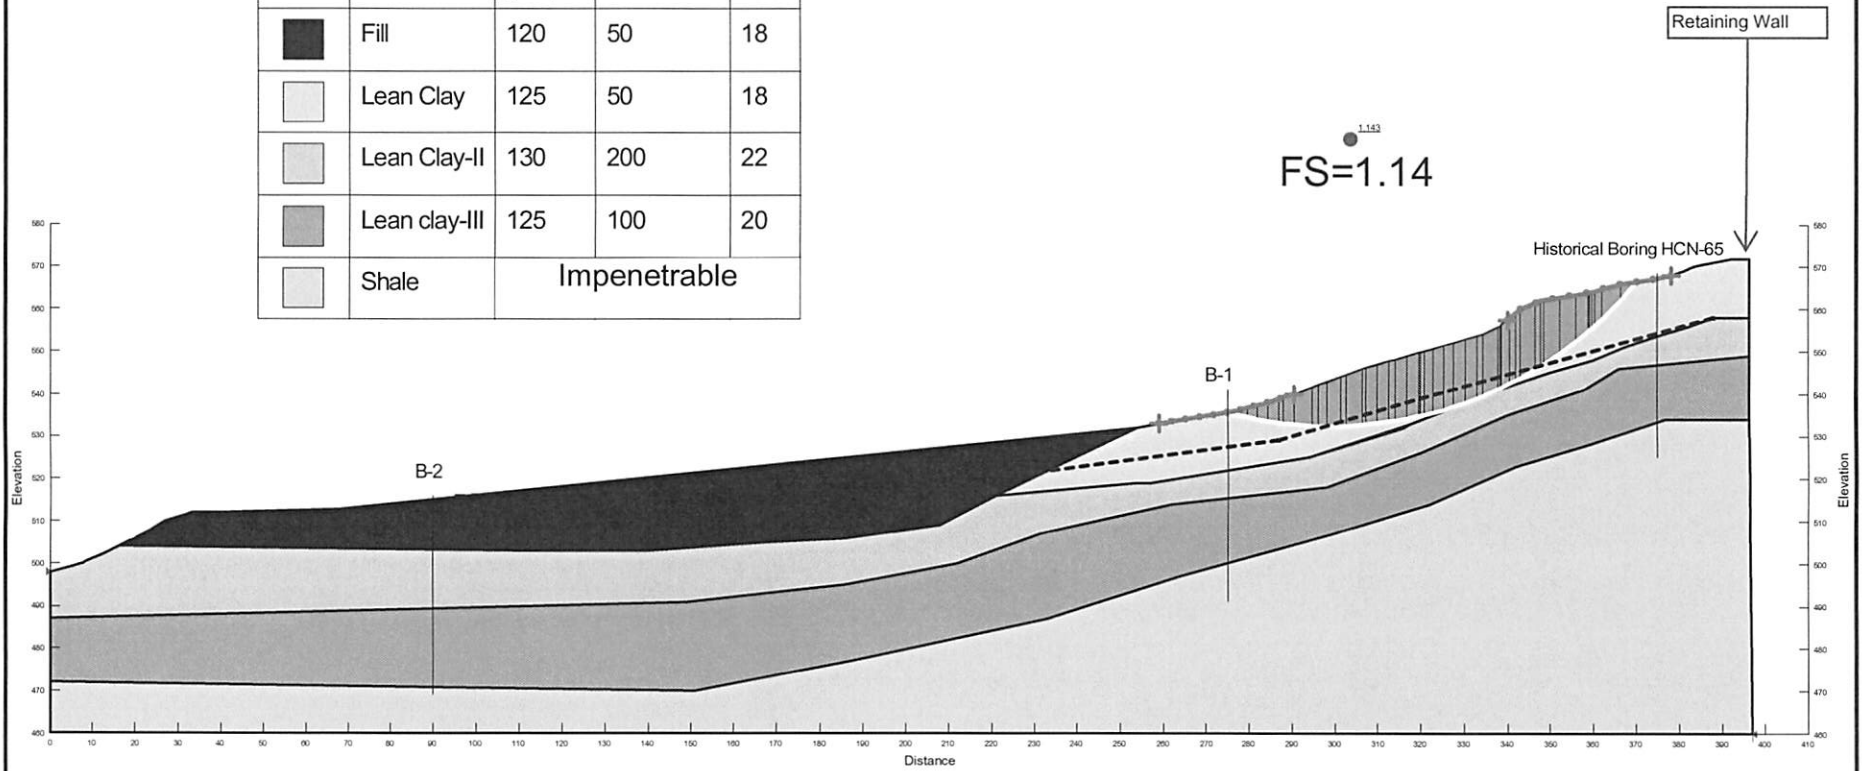
Color	Name	Unit Weight (pcf)	Cohesion' (psf)	Phi' (°)
■	Fill	120	50	18
□	Lean Clay	125	50	18
□	Lean Clay-II	130	200	22
■	Lean clay-III	125	100	20
□	Shale	Impenetrable

Terracon Project Number : N1185144
Project Name : Walworth Avenue Development
Cross Section with Borings B-1 and B-2

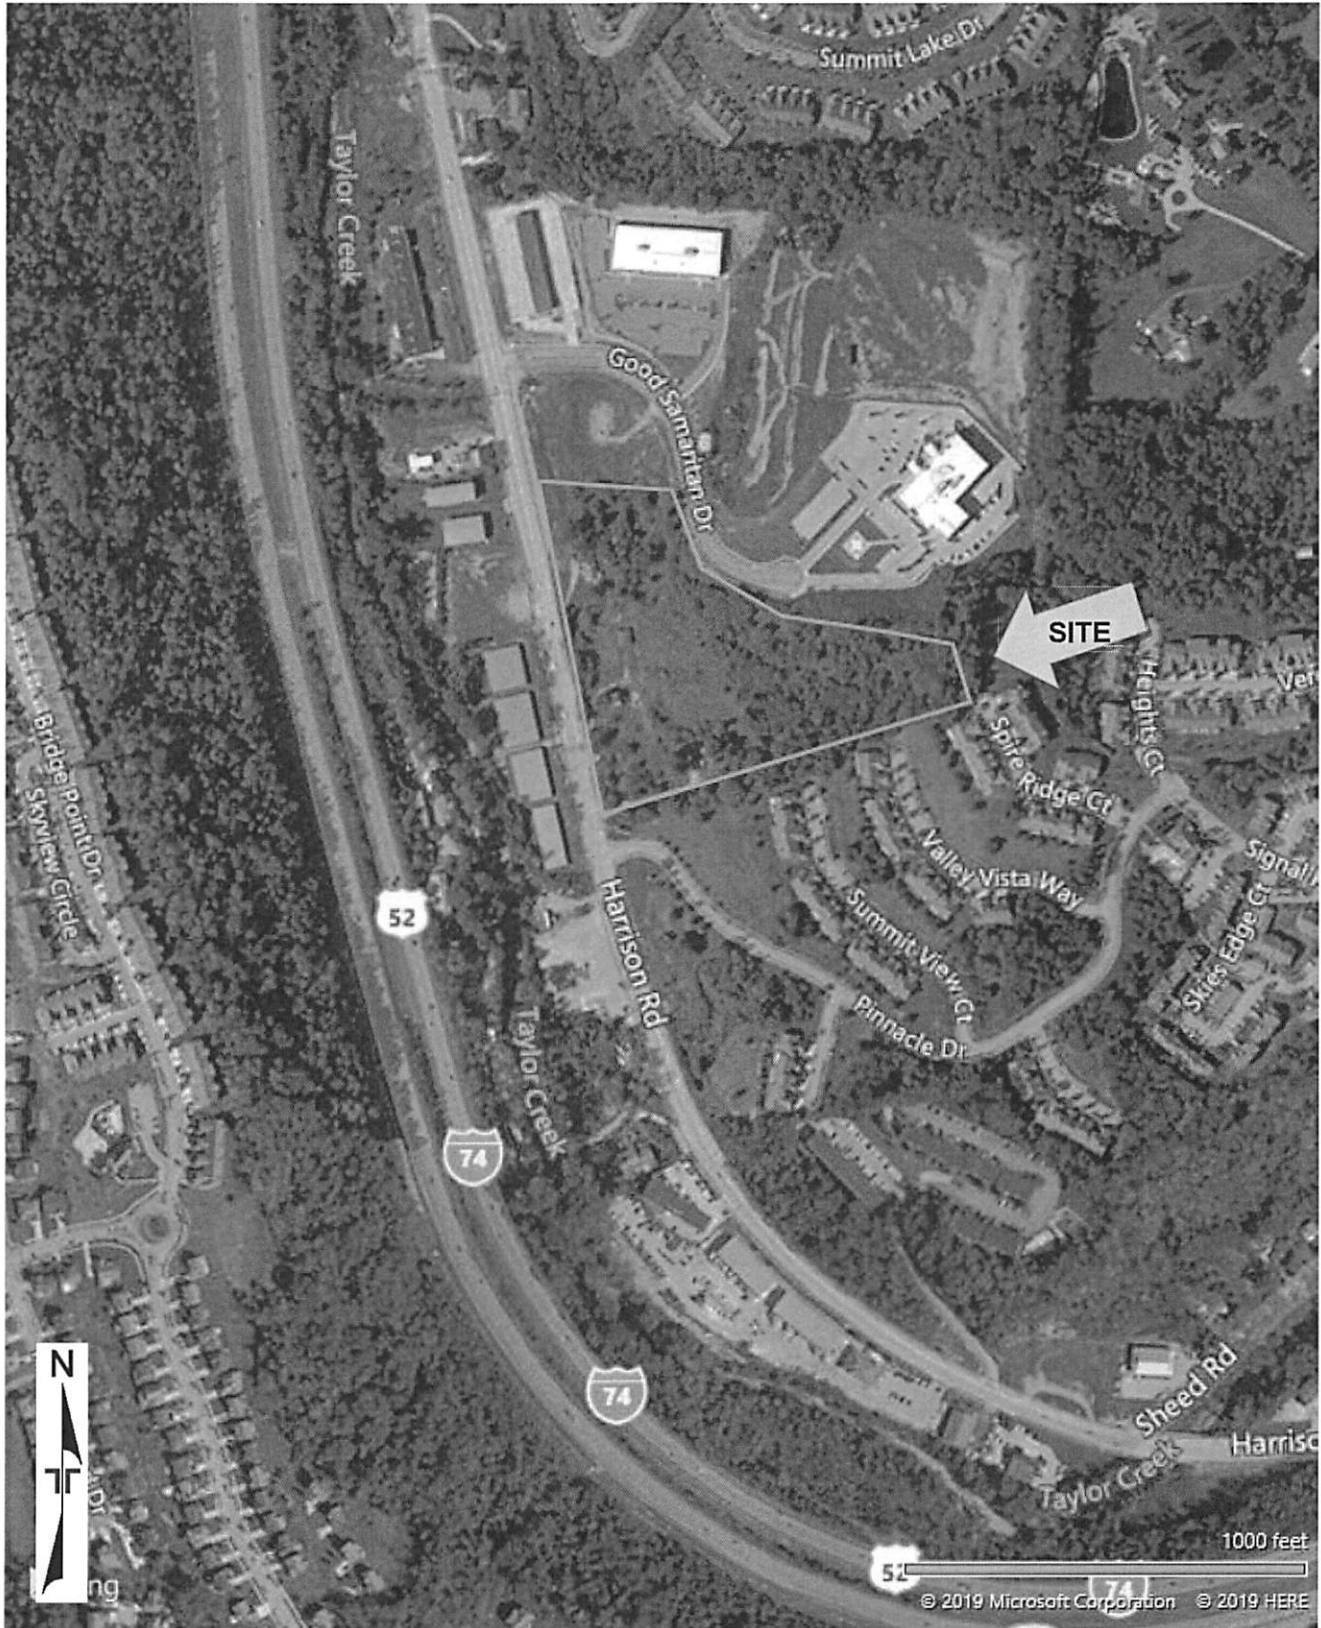
EXPLORATION PLAN - OH-128 SITE
Walworth Development - Borrow Sites in Cincinnati, Hamilton County, Ohio
April 25, 2019 in Terracon Project No. N1185144
