Subject: Presentation – 2200 Block of Harrison Avenue – Crash Data and Recommendations

2200 Block of Harrison Avenue – Crash Data and Recommendations

Education, Innovation, and Growth Committee October 4, 2021

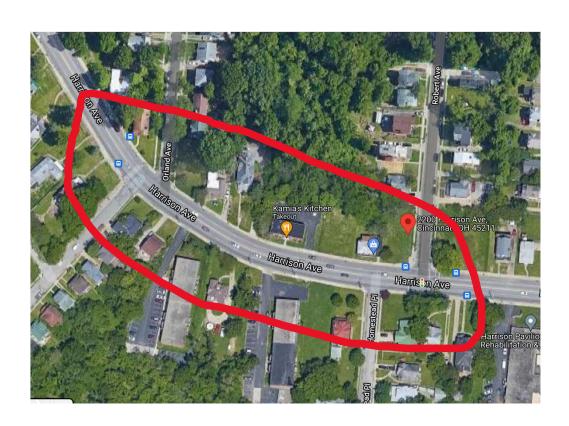
Recent crashes in the 2200 block of Harrison Ave between Robert Ave and Orland Ave in the Westwood neighborhood.

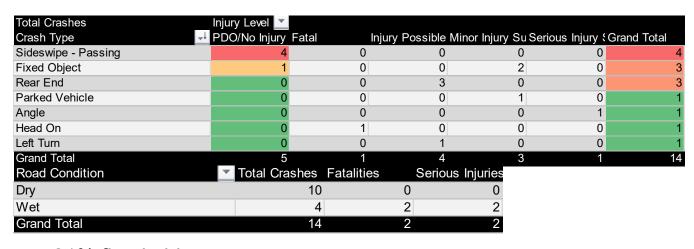
- 21% fixed object
- 28% wet weather

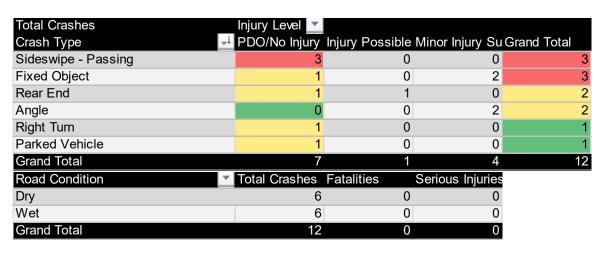
- 25% fixed object
- 50% wet weather

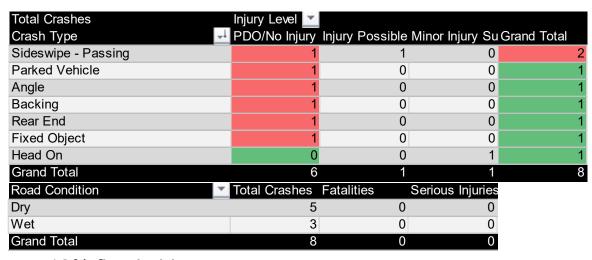
- 12% fixed object
- 38% wet weather

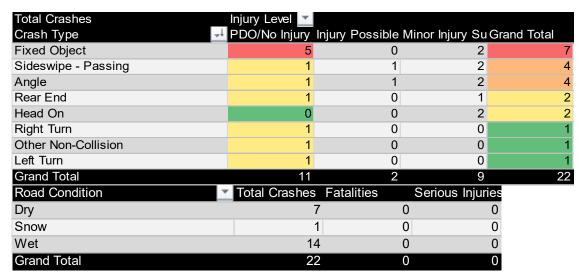
- 36% fixed object
- 68% wet weather

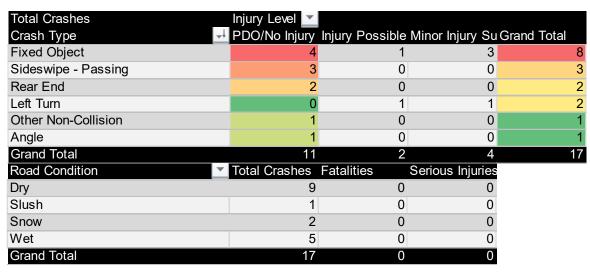
Crash Statistics by Type: January - August 2021

- 53% fixed object
- 47% wet weather

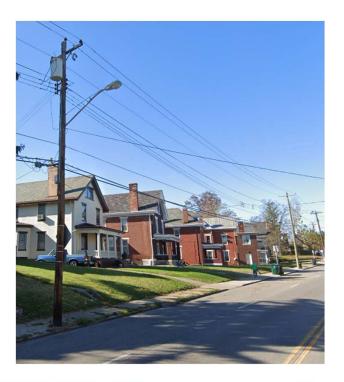
1. Improved streetlighting

- Duke Energy recently replaced two utility poles and added one new pole:
 - Streetlights missing on two replacements
 - DOTE has asked Duke to replace both lights
 - DOTE to ask Duke to add new light to new pole
 - Est. cost: \$2000
 - DOTE to use existing funds

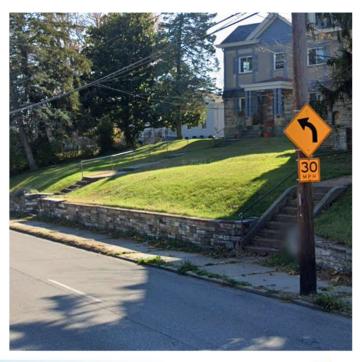
2. Upgraded/updated signage

- Some missing signage installed summer 2020
- Additional signage to be installed to help drivers navigate roadway
 - Est. cost: \$1,000
- Replace existing signage with new higher reflective signage:
 - Est. cost: \$1,000
 - DOTE to use existing funds

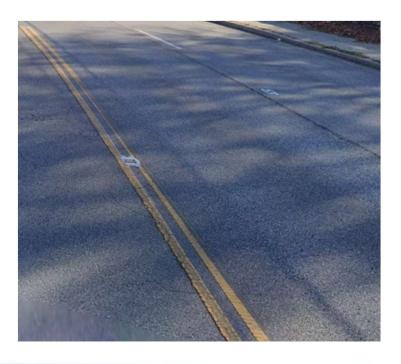
3. Pavement Markings

- Existing markings in average to good condition
- Restriping would improve visibility
 - Est. cost: \$15,000
- Raised Pavement Markings (RPMs)
 - Increase visibility at night/in wet weather
 - Replace reflectors in the existing RPMs
 - Est. cost: \$50,000
- Additional funding needed

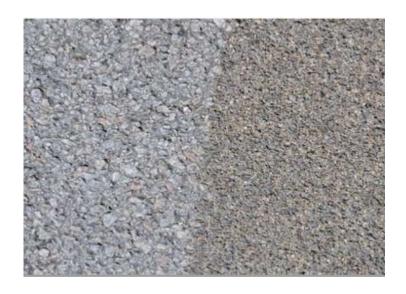
4. High Friction Surface Treatment

- Topcoat with rougher texture/better traction
- Most effective countermeasure for locations with lots of wet pavement crashes
 - Est. cost: \$300,000
 - Earliest installation: June 2022
- Additional funding needed
