2200 Block of Harrison Avenue – Crash Data and Recommendations

Education, Innovation, and Growth Committee
October 4, 2021

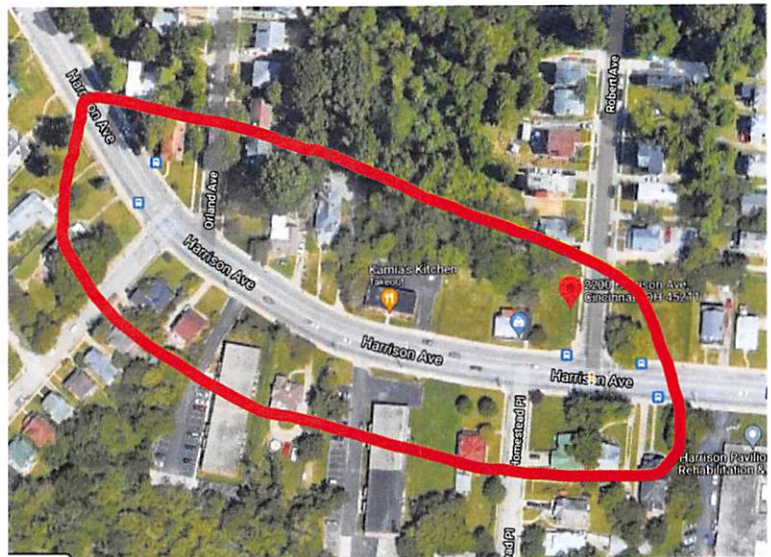
- Recent crashes in the 2200 block of Harrison Ave between Robert Ave and Orland Ave in the Westwood neighborhood.

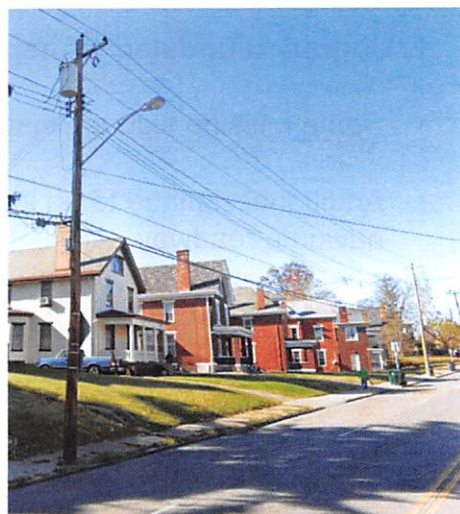
1. Improved streetlighting

- Duke Energy recently replaced two utility poles and added one new pole:
 - Streetlights missing on two replacements
 - DOTE has asked Duke to replace both lights
 - DOTE to ask Duke to add new light to new pole
 - Est. cost: \$2000
 - DOTE to use existing funds

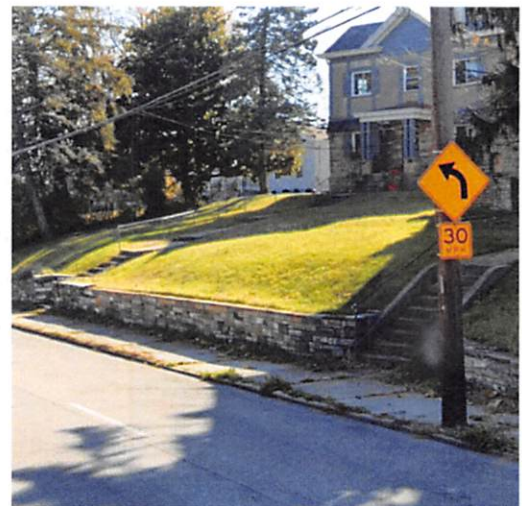
2. Upgraded/updated signage

- Some missing signage installed summer 2020
- Additional signage to be installed to help drivers navigate roadway
 - Est. cost: \$1,000
- Replace existing signage with new higher reflective signage:
 - Est. cost: \$1,000
 - DOTE to use existing funds

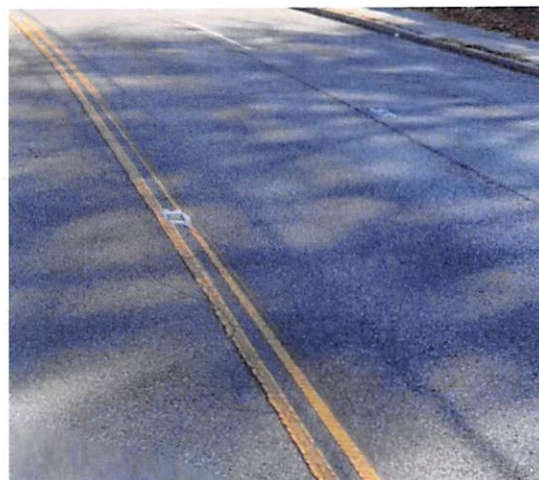
3. Pavement Markings

- Existing markings in average to good condition
- Restriping would improve visibility
 - Est. cost: \$15,000
- Raised Pavement Markings (RPMs)
 - Increase visibility at night/in wet weather
 - Replace reflectors in the existing RPMs
 - Est. cost: \$50,000
- Additional funding needed

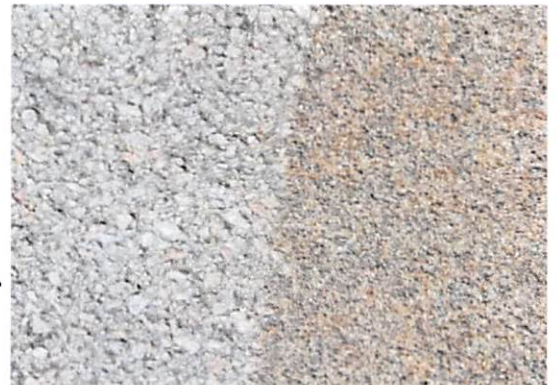
4. High Friction Surface Treatment

- Topcoat with rougher texture/better traction
- Most effective countermeasure for locations with lots of wet pavement crashes
 - Est. cost: \$300,000
 - Earliest installation: June 2022
- Additional funding needed
