This report presents the findings and recommendations for local landmark designation of the South Crescent Arms Apartments, AKA The Redding. The building is located at 3700 Reading Road in Avondale. This report was prepared by Beth Sullebarger on behalf of City Studios Architecture.

HISTORIC CONSERVATION GUIDELINES

South Crescent Arms AKA The Redding Apartments

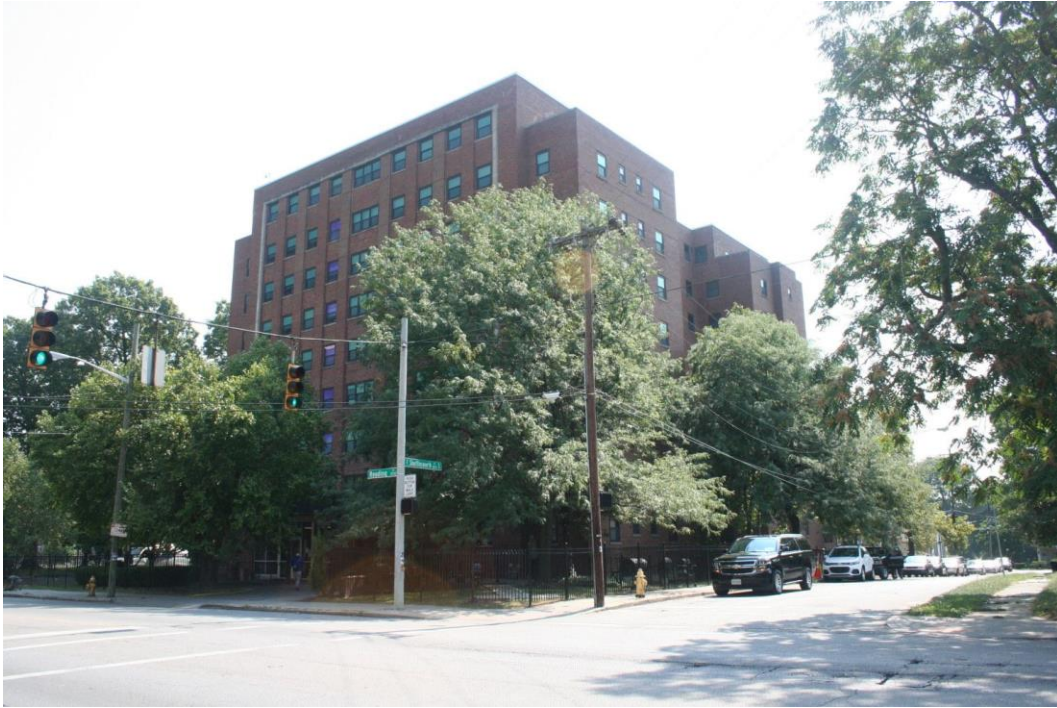
3700 Reading Road, Front (West) and South elevations

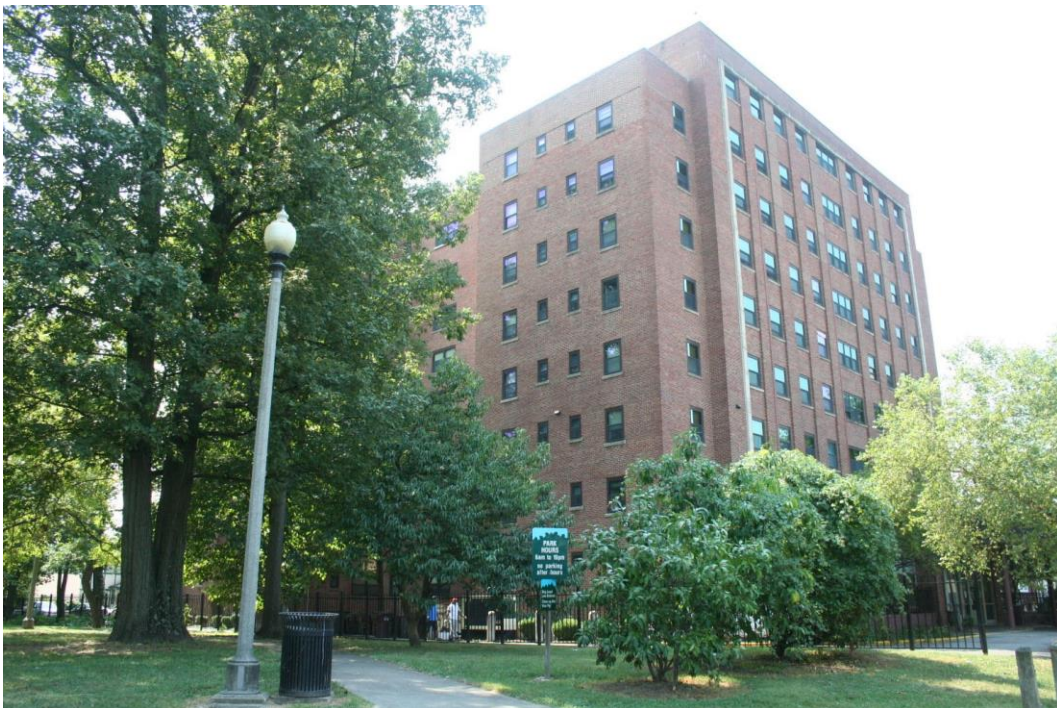
3700 Reading Road, North and East (Front) elevations

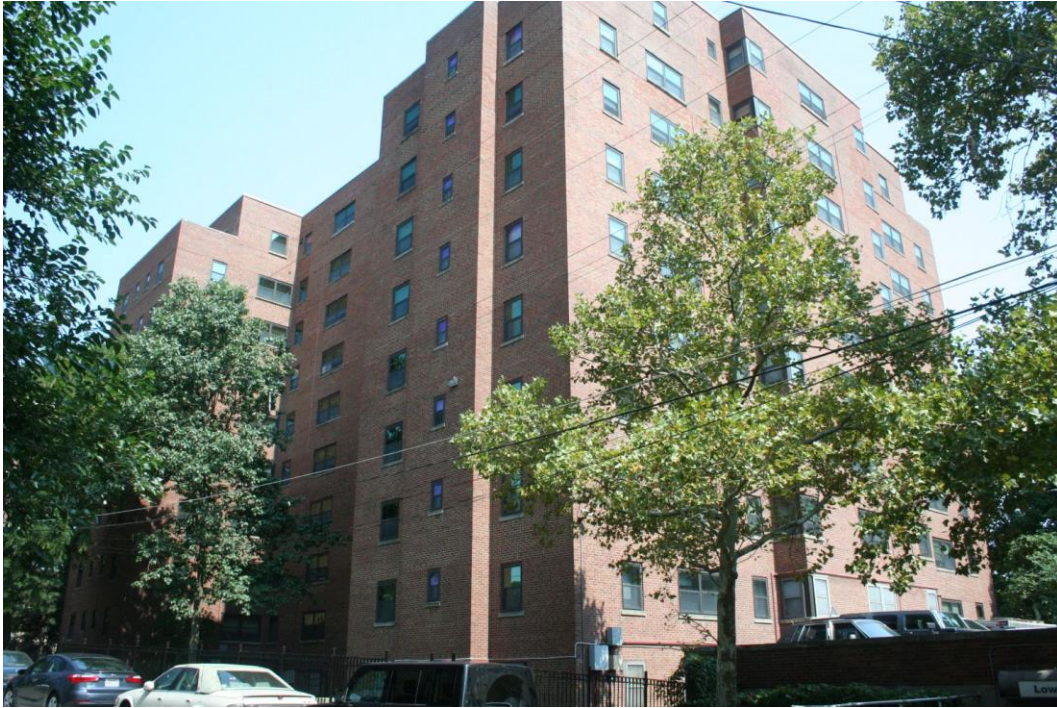
3700 Reading Road, South and Rear (East) elevations

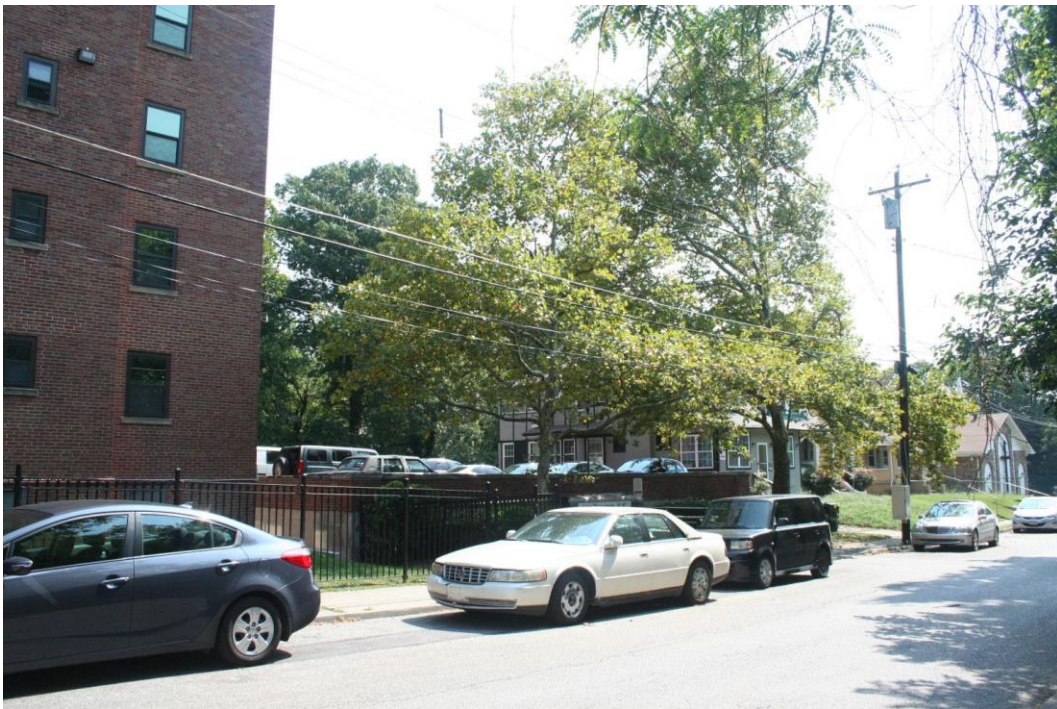
3700 Reading Road, view of parking garage to the east

Ornament is limited to a simple contrasting limestone trim that outlines the center section of the facade. The entrance is emphasized by a porte cochere and projecting one-story vestibule. The building ends in a flat parapet wall with stone coping. The deep side elevations each extend for 12 bays with a recessed four-bay section in the center. All elevations are characterized by regular fenestration with one-over-one aluminum windows. To the rear of the building is a partly below-grade, two-level reinforced-concrete parking deck with flared mushroom columns.
